**NATIONAL TRANSPORTATION SAFETY BOARD
WASHINGTON, D.C.**

**METALLURGY/STRUCTURAL GROUP CHAIRMAN
FACTUAL REPORT
SEQUENCING STUDY
(57 pages)**

METALLURGY / STRUCTURES SEQUENCING STUDY

Place : East Moriches, New York
Date : July 17, 1996
Airplane : Boeing 747-131, N93119
NTSB No. : DCA96-M-A070

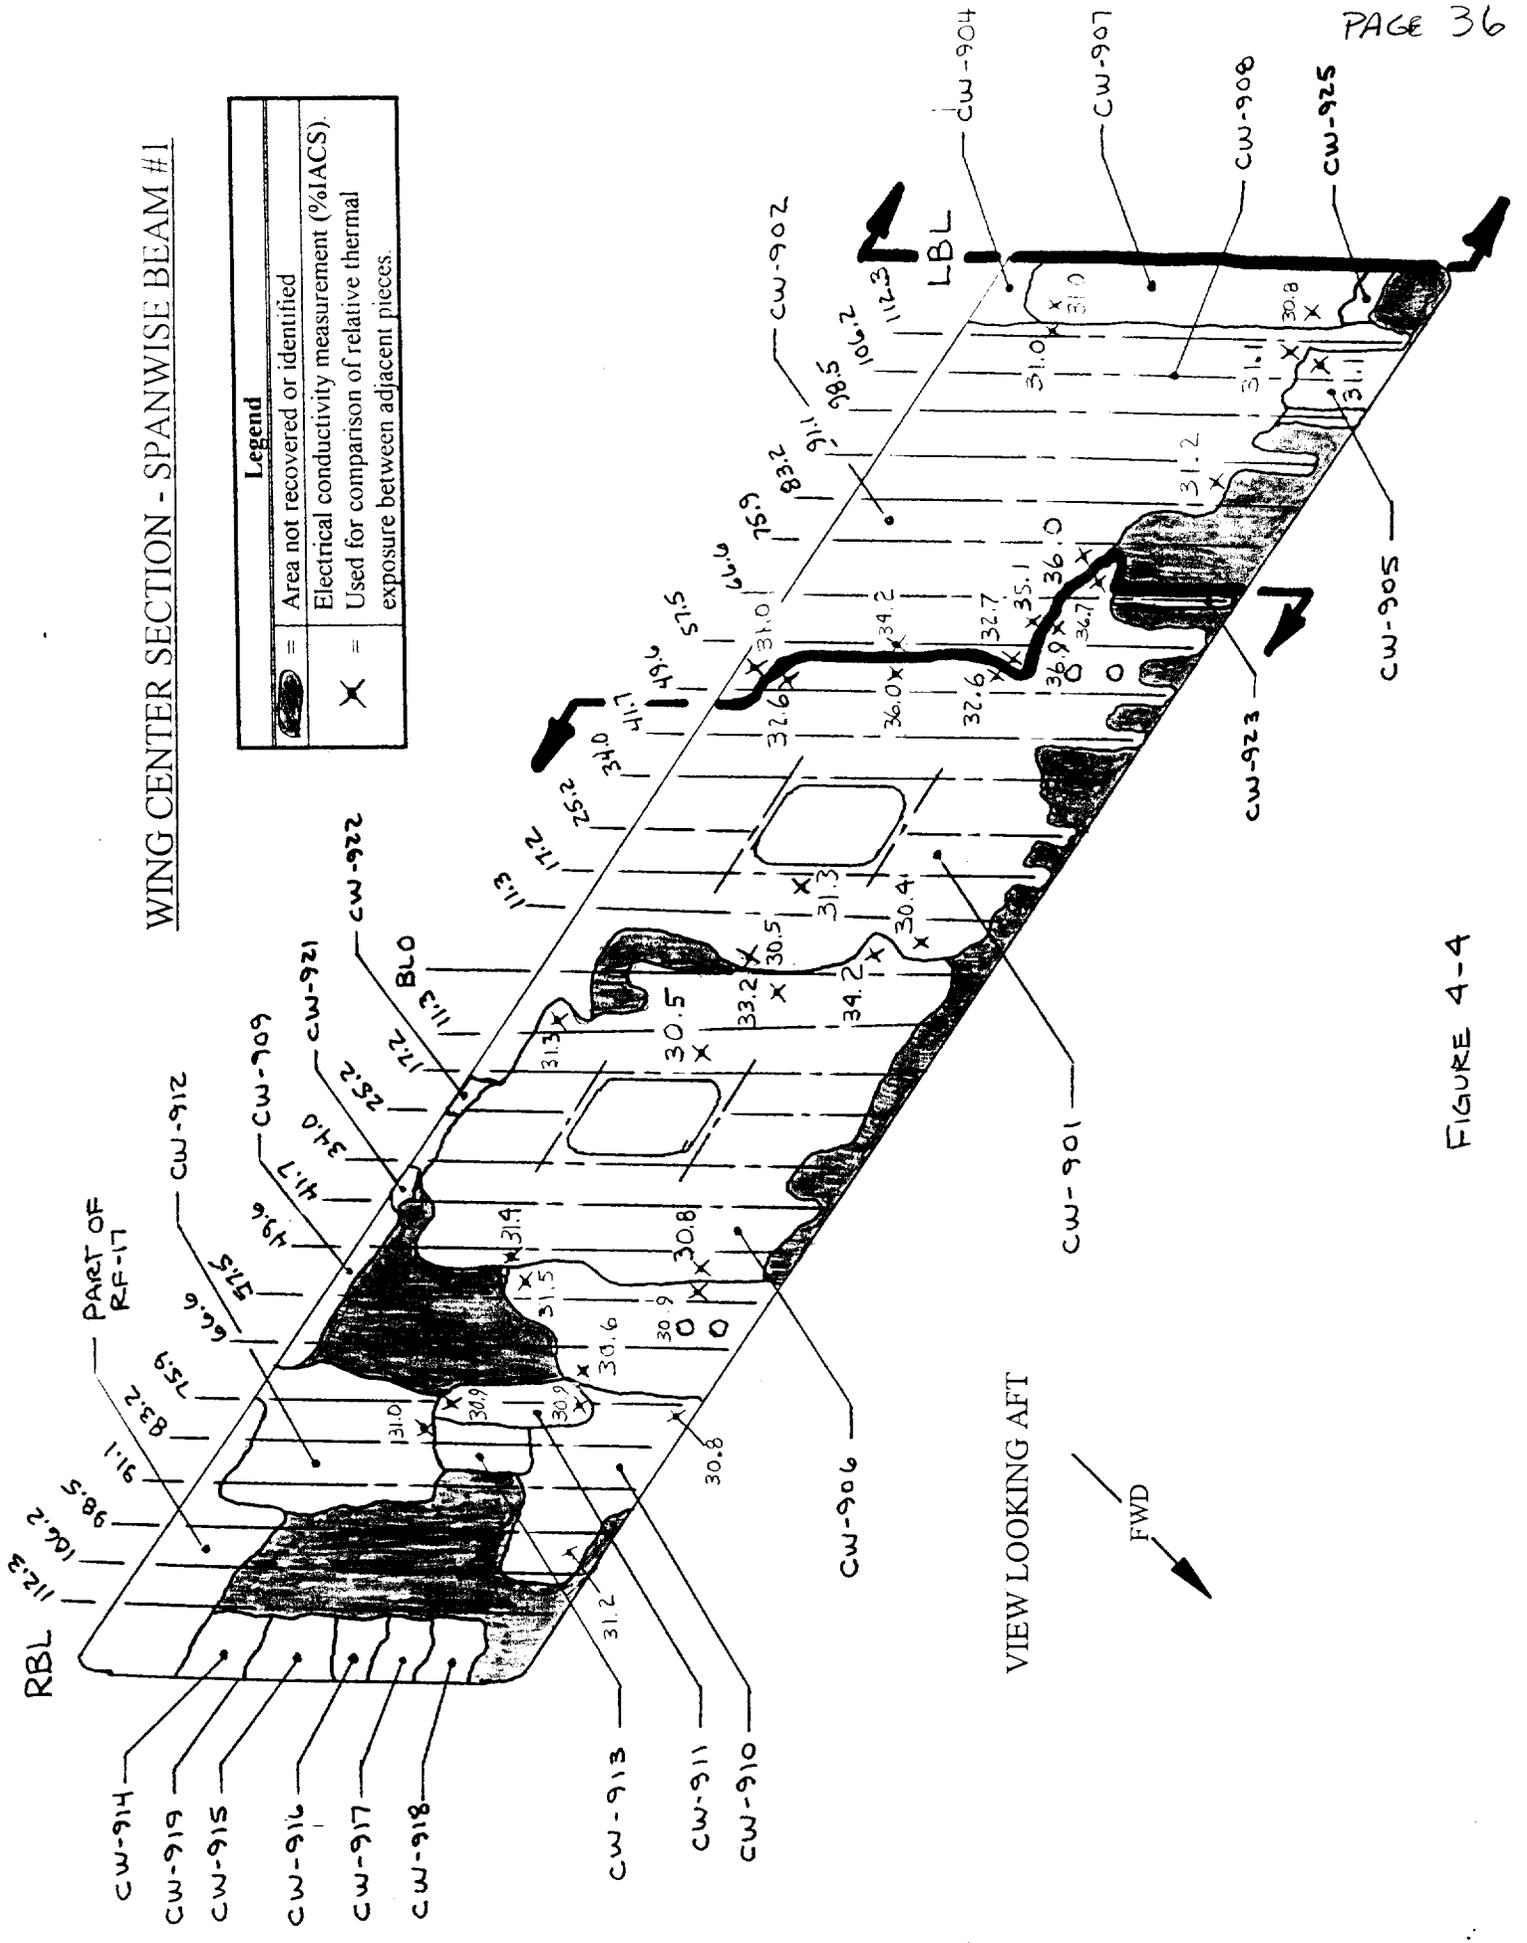
FIGURE 4-4

Spanwise beam #1 (SWB#1) is approximately 90% recovered and identified, with the majority of missing material on the right side and the remainder mostly distributed full span across the lower portion of the beam. Sooting varies from clean to heavy on both the forward and aft surfaces of SWB#1 with a number of mating fracture faces equally sooted. A review of sooting patterns, electrical conductivity readings, and crack morphology indicates there were likely multiple failures at the time of major airplane breakup (RBL 66 to LBL 57). The portion of SWB#1 between the left side of body and approximately LBL 57 either separated independently during wing breakup or remained attached to the right wing for a time after major airplane breakup (see figure 4-4).

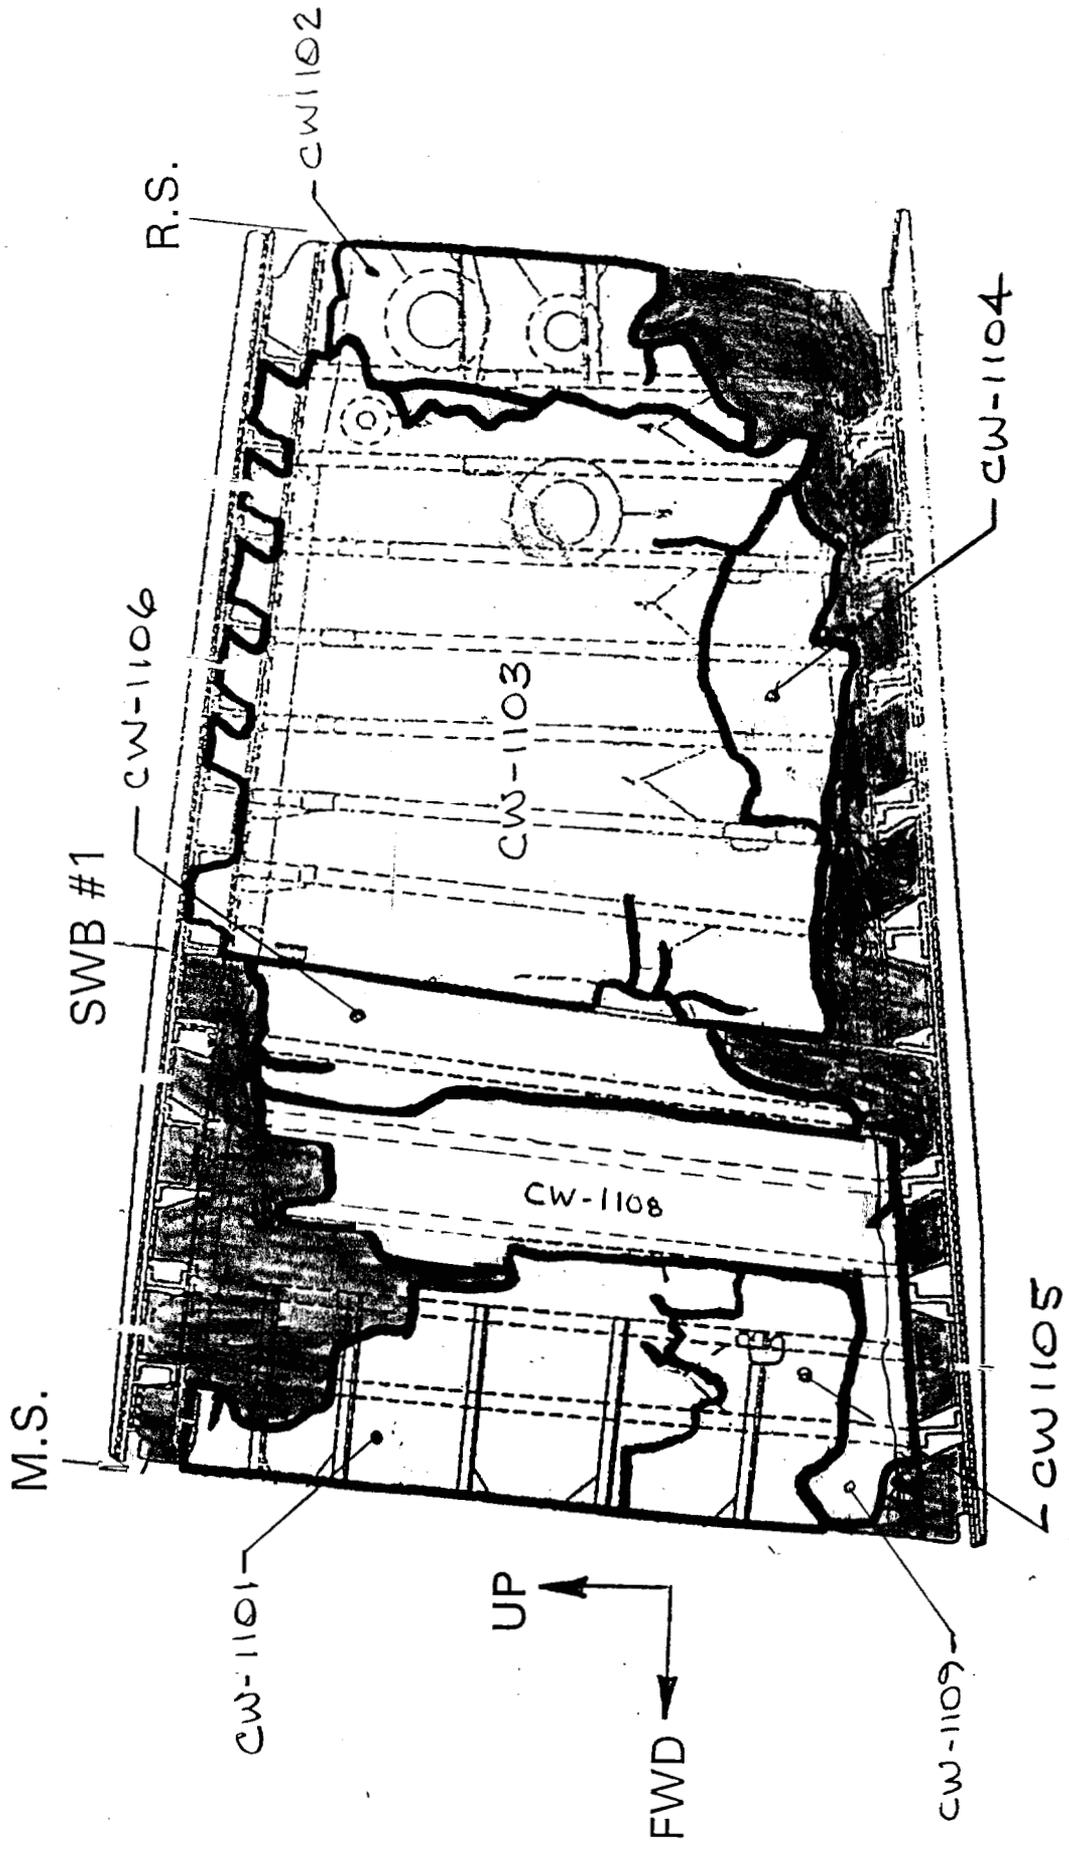
FIGURE 4-6

Approximately 90% of the centerline rib between the rear spar and SWB#1 has been recovered and identified but only 40% of the rib between SWB#1 and midspar (see figure 4-6). The section between rear spar and SWB#1 is heavily sooted on forward, aft, and upper fracture faces. The pieces between SWB#1 and midspar are equally heavily sooted on both the left and right surfaces and most fracture faces. Sooting and the location and features of fractures indicate the centerline rib remained with the right wing at major airplane breakup. Definitive damage or sooting prior to major airplane breakup could not be identified, however see the sections on SWB#1 (section 4.6) and the midspar (section 4.7) for discussion of indications of earlier damage on these components, which may have also related to the centerline rib. There were indications described of an overpressure acting aft on SWB#1 and early presence of fire or soot ahead of SWB#1, either of which might have affected the centerline rib.

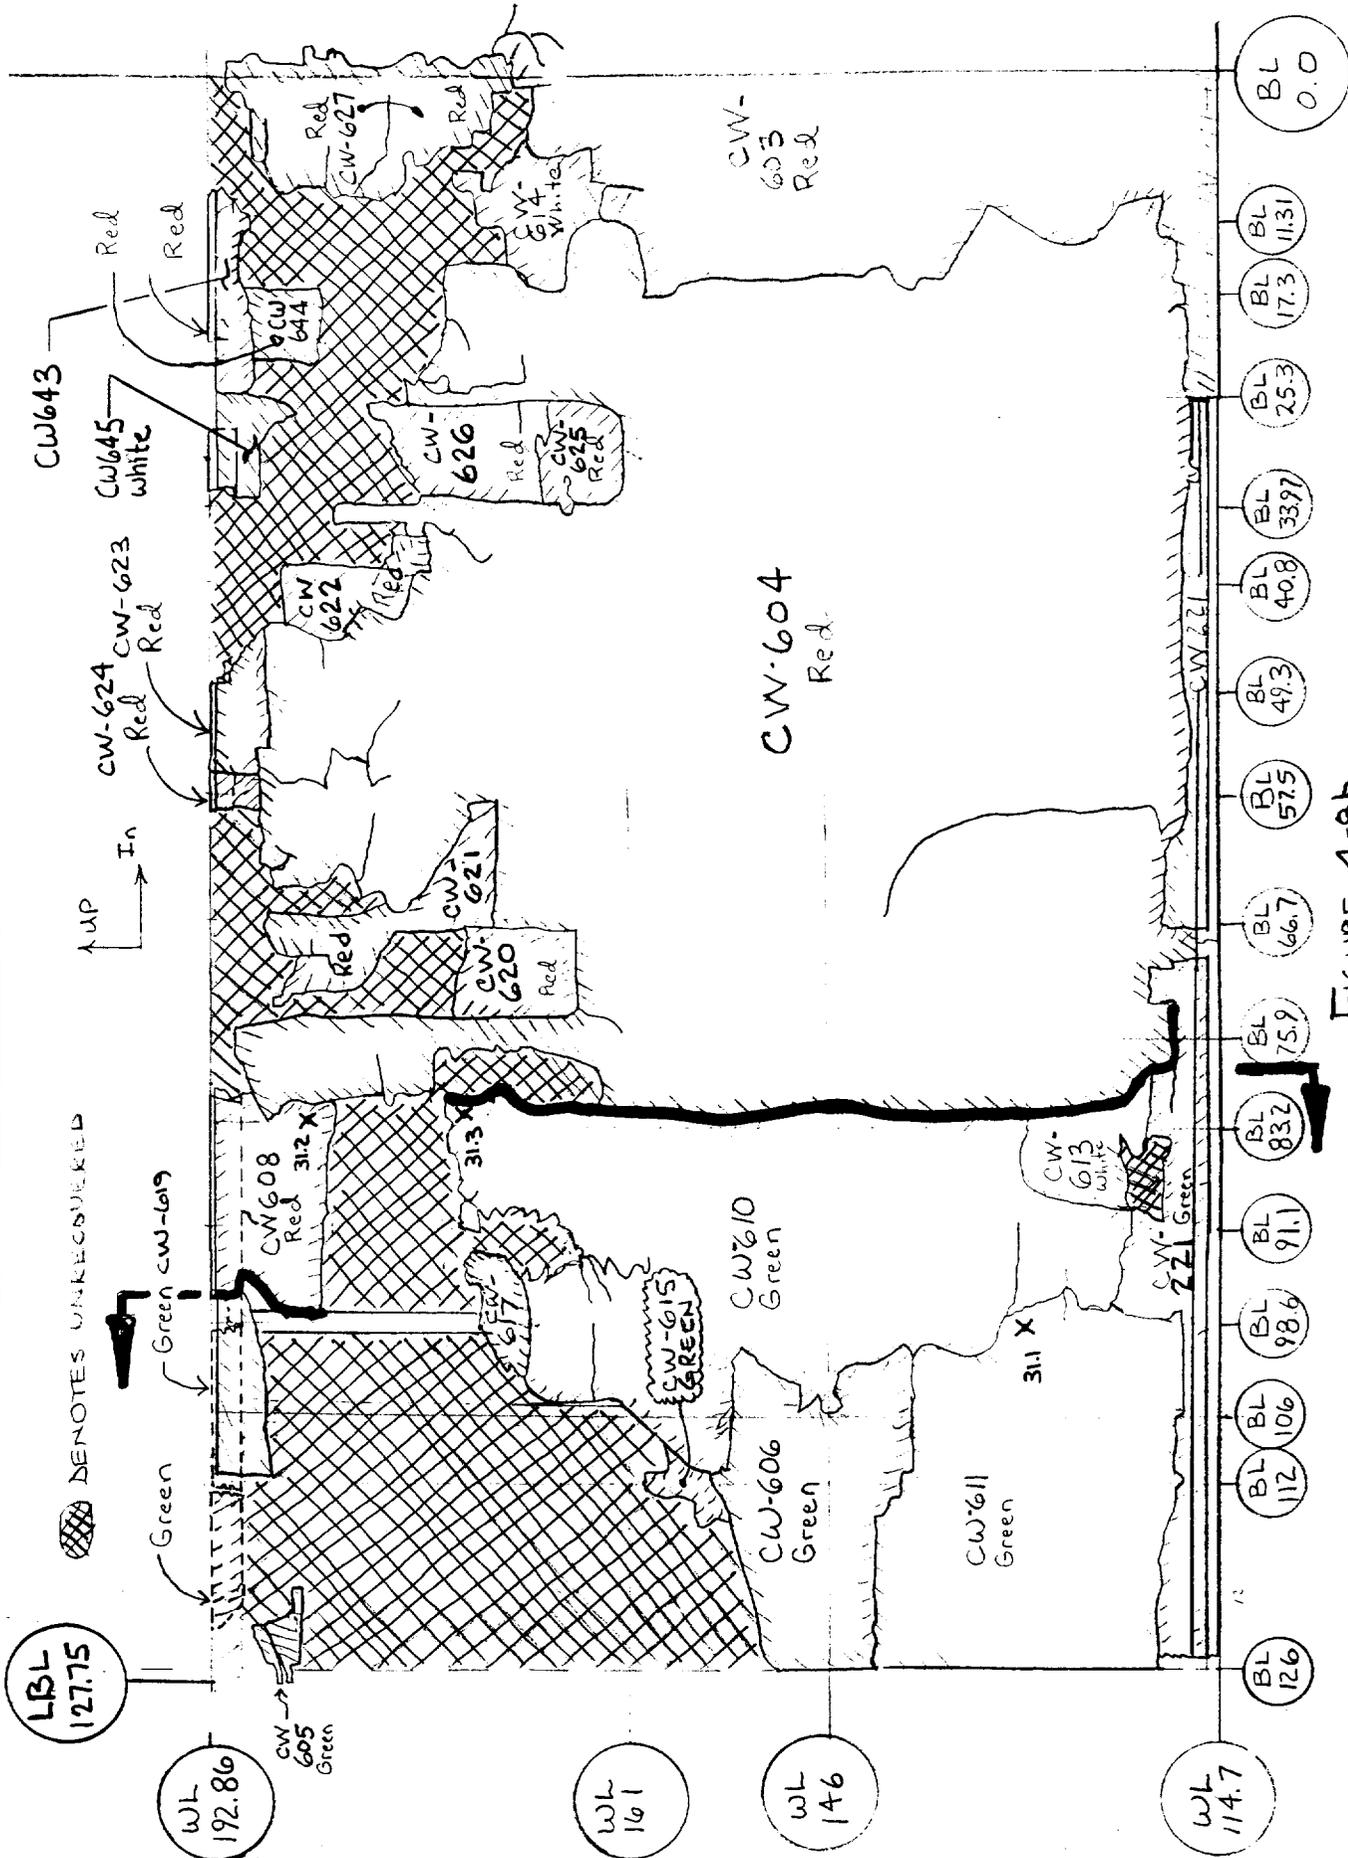
FIGURE 4-8b

Spanwise beam #3 (SWB#3) is approximately 85% recovered with most of the missing area located between RBL 50 and RBL 90 (see figure 4-8). Pieces of the beam between approximately RBL 50 and LBL 80 were recovered from the red area indicating relatively early departure from the airplane. The part of SWB#3 from RBL 87 to right side-of-body is heavily sooted (burn damage) on both surfaces as well as most fracture faces. The pieces recovered from the red area are generally lightly sooted on both faces with occasionally more sooting on the front face. The pieces between LBL 80 and the left side-of-body (green area) are moderately sooted. Piece CW611 (adjacent to the left side-of-body) exhibits soot tails above the protruding fastener heads on the front surface. During major airplane breakup the pieces outboard of LBL 80 went with left wing and the pieces outboard of RBL 75 with right wing. The sooting on the aft surface on the left side and on red area pieces is indicative of an earlier event. Larger amounts of soot accumulation and fire damage on the right wing pieces indicate that this portion

The upper chord for SWB#3 was fractured through the fillet radius between the vertical leg and the upper horizontal leg of the chord. The upper chord fracture initiated at multiple locations and progressed essentially the full width of the beam.

Vertical fractures through SWB#3 were found at various locations including near the respective sides-of-body. These fractures are also consistent with a forward acting overpressure on the aft surface of SWB#3. Separation of the top of the SWB#3 allowed the segments to rotate forward about the lower intercostals (or, in the case of the center segment, about the beam's lower chord) until the top of the beam impacted the stiffeners on the aft surface of the front spar approximately 12" below the upper skin panel. The impact broke off parts of the upper web and stiffeners of SWB#3. The remaining lower portion of SWB#3 continued rotating forward and down with upper stiffener ends tearing vertical holes in the front spar web at various locations down to about 1 to 2 feet from the lower panel.

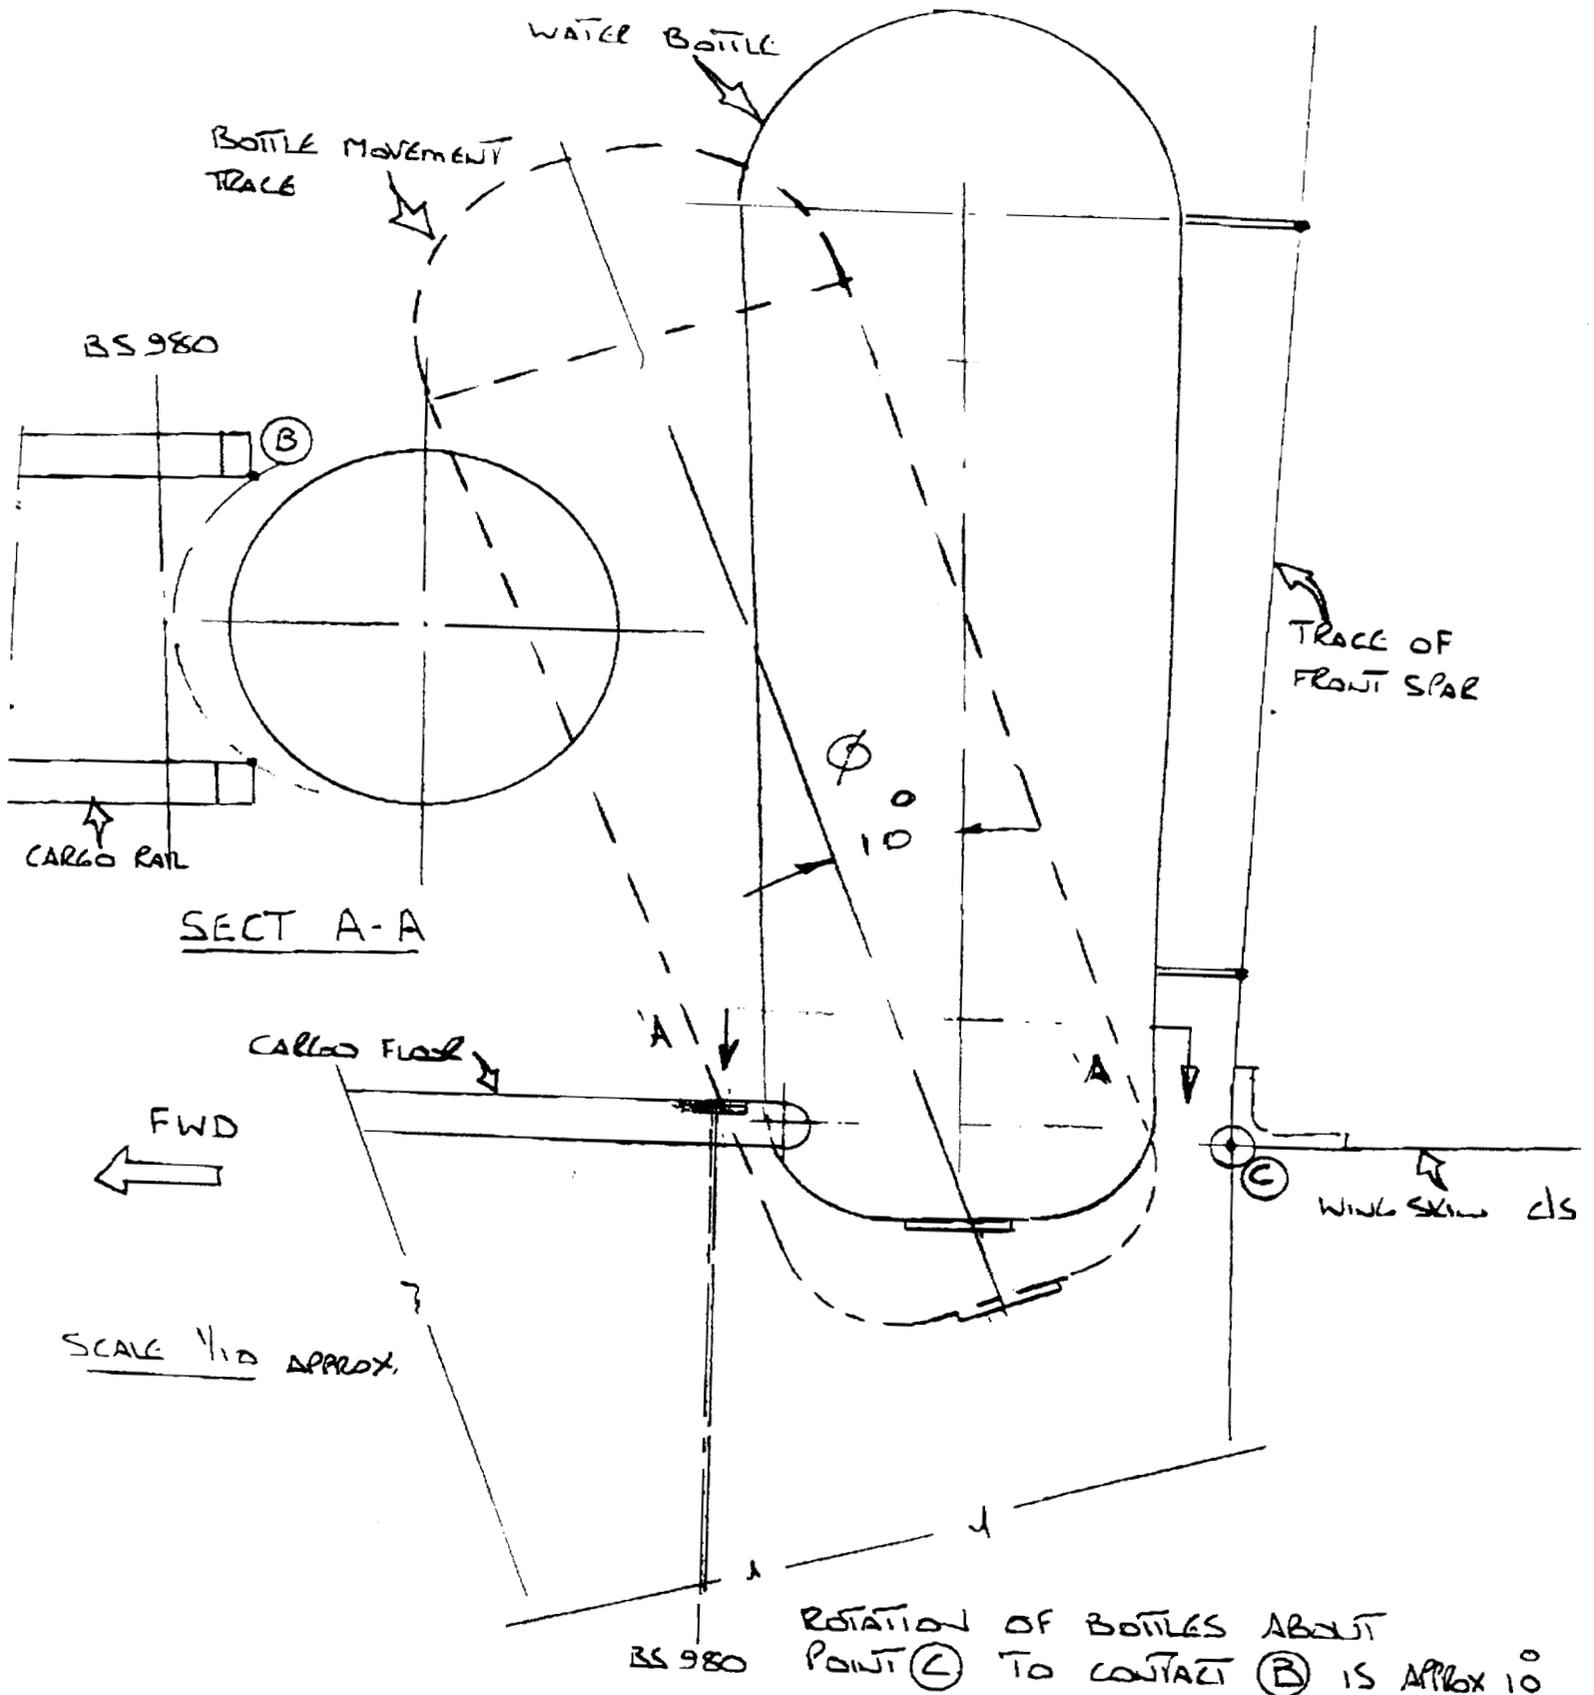
FIGURE 4-10

As discussed in section 4.10, SWB#3 rotated forward impacting the vertical stiffeners on the aft surface of the front spar. The impact, along with possible overpressure from behind SWB#3 fractured the front spar upper chord in the radius between the horizontal and vertical legs of the chord. The horizontal leg of the chord remained attached to the upper skin panel, and the vertical leg remained attached to the web of the front spar. Continued forward and downward rotation of SWB#3 tore holes in the front spar web, at various locations down to about 1 to 2 feet from the lower panel. Geometric layouts (see Appendix B) indicate that SWB#3 probably rotated almost fully forward and down prior to full rotation of the front spar about its connection to the WCS lower panel. The potable water bottles (centered on the front surface of the front spar) sustained relatively minor damage on their aft sides from impact with pieces of SWB#3. The forward side of the right bottle contained impact marks and fractures roughly corresponding to cargo floor structure. A geometric layout indicates that only about 10 degrees of rotation of the front spar would be needed to force contact between the bottles and the cargo floor structure (see figure 4-10).

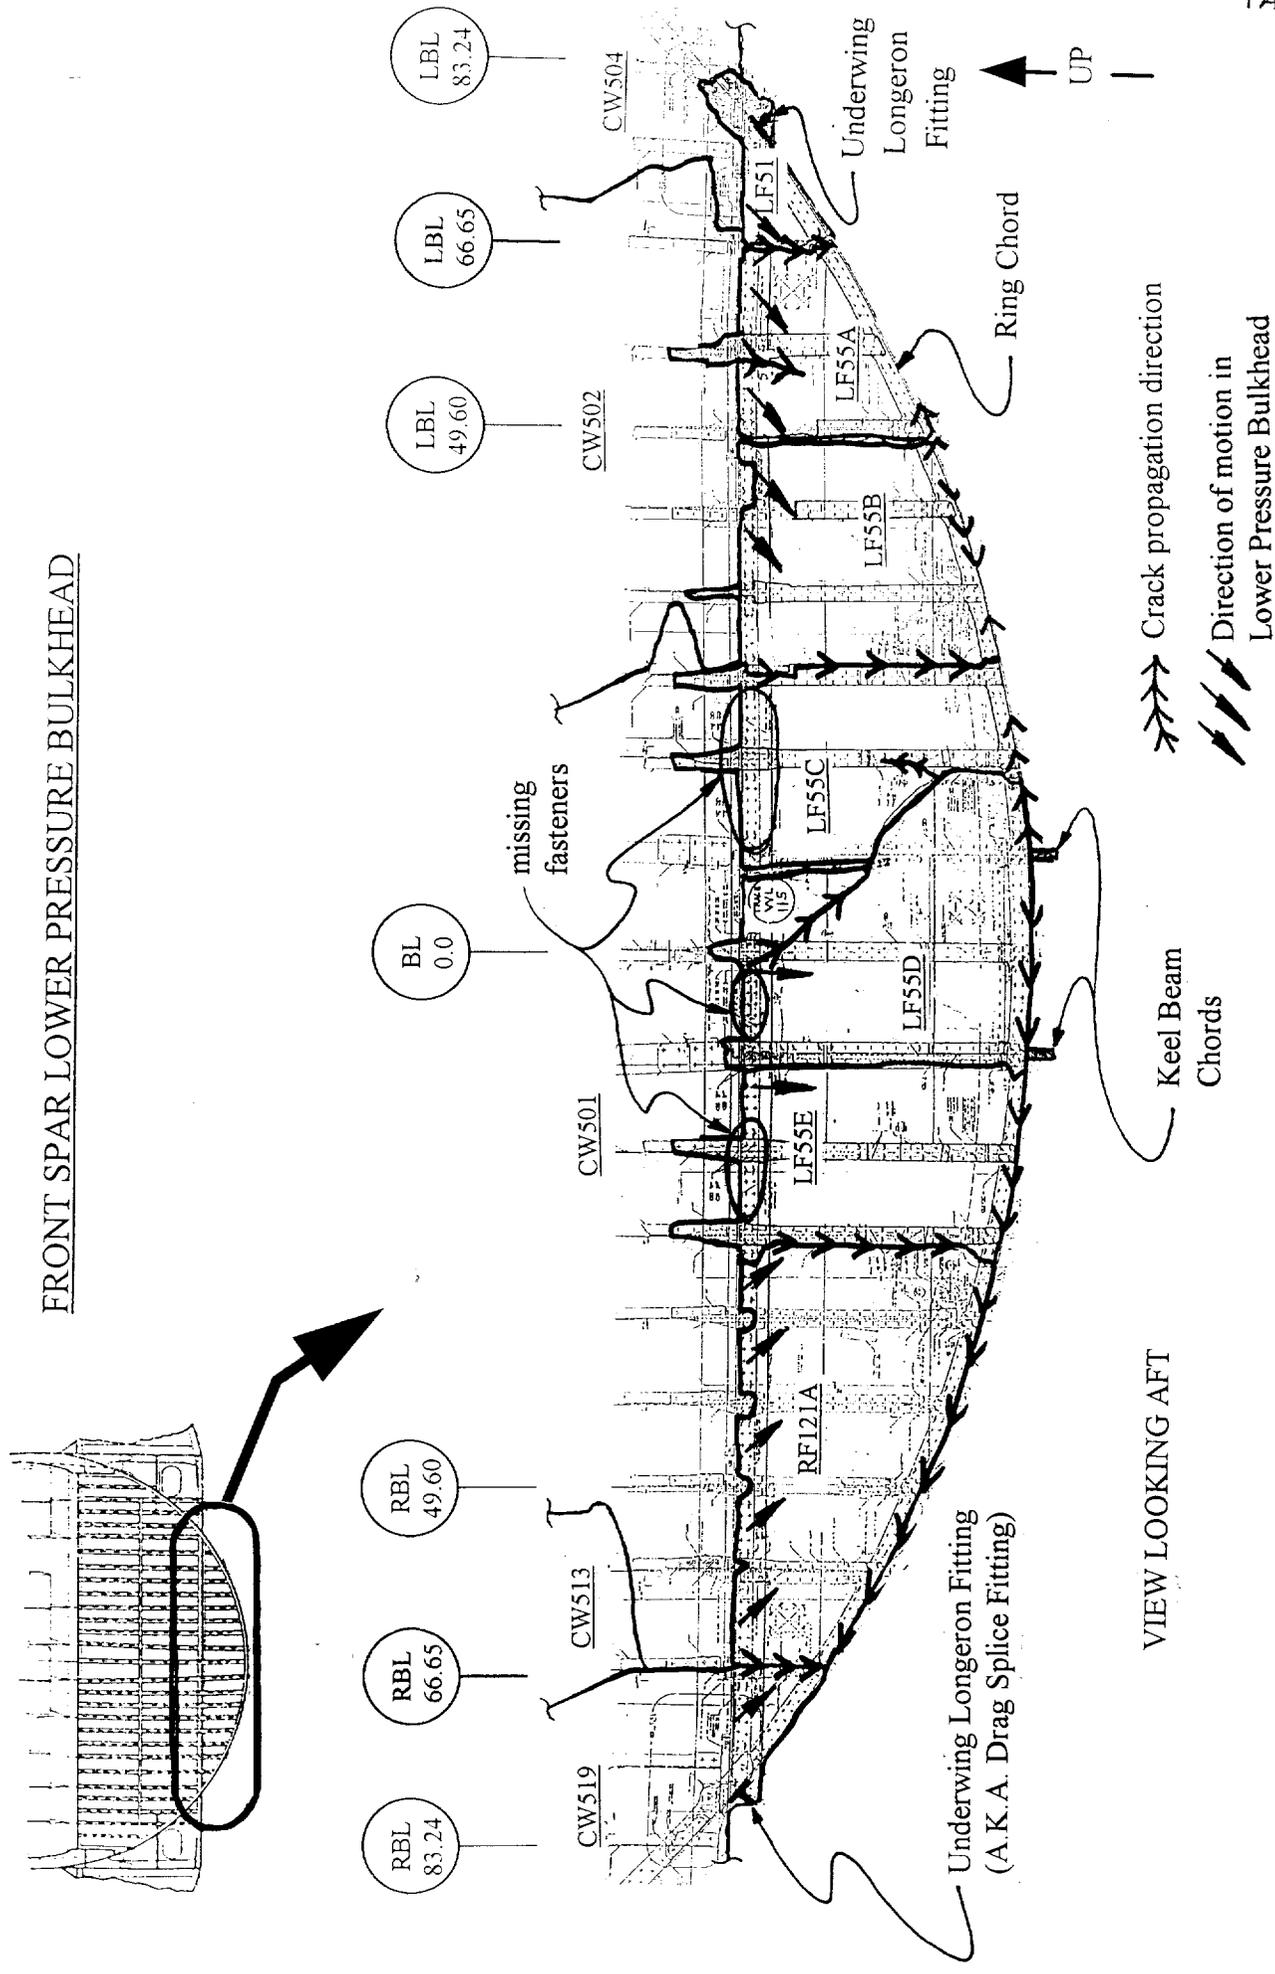
FIGURE 4-11

adjacent fittings stayed with the airplane and were recovered from the green area. The aft surface of the lower pressure bulkhead pieces to the left of the keel beam had soot deposits, especially on the upper edges of protruding head fasteners and on other protruding objects. Some soot was also noted on the aft surface of the bulkhead to the right of the keel beam. Crack propagation directions have been identified and documented on Figure 4-11.

At RBL 66, LBL 26, and LBL 66 web cracks propagated down from the front spar web and reinitiated downward in the lower pressure bulkhead with eventual associated axial fracture of the ring chord. There are additional lower bulkhead fractures at RBL 9 and LBL 9 which are close to the keel beam interface. There is an additional vertical web crack at LBL 49 which is associated with the separation of piece LF55A. The stiffeners “splicing” webs of the front spar and lower bulkhead are uniformly buckled in the free flange consistent with the motion of the front spar rotating forward. The stiffener at LBL18 is not bent forward as far as the others indicating limited forward rotation of the front spar in this area prior to ring chord separation at the bottom of the stiffener. The fasteners common to the splice between the webs of the front spar and lower pressure bulkhead are consistently (left and right sides, BL26 to BL75) separated in shear with the lower web being pulled downward and somewhat inboard.

There are two bathtub fittings nested in the ring chord above the underwing longeron. These joints have fractured in a tension/bending mode consistent with the fuselage skin panels forward of the fittings rotating outward about the ring chord, applying a bending moment which is reacted between these fittings (tension) and the longeron fitting. The bathtub fittings appear to have separated first then the longeron joint in a manner consistent with being overloaded by the same bending moment.

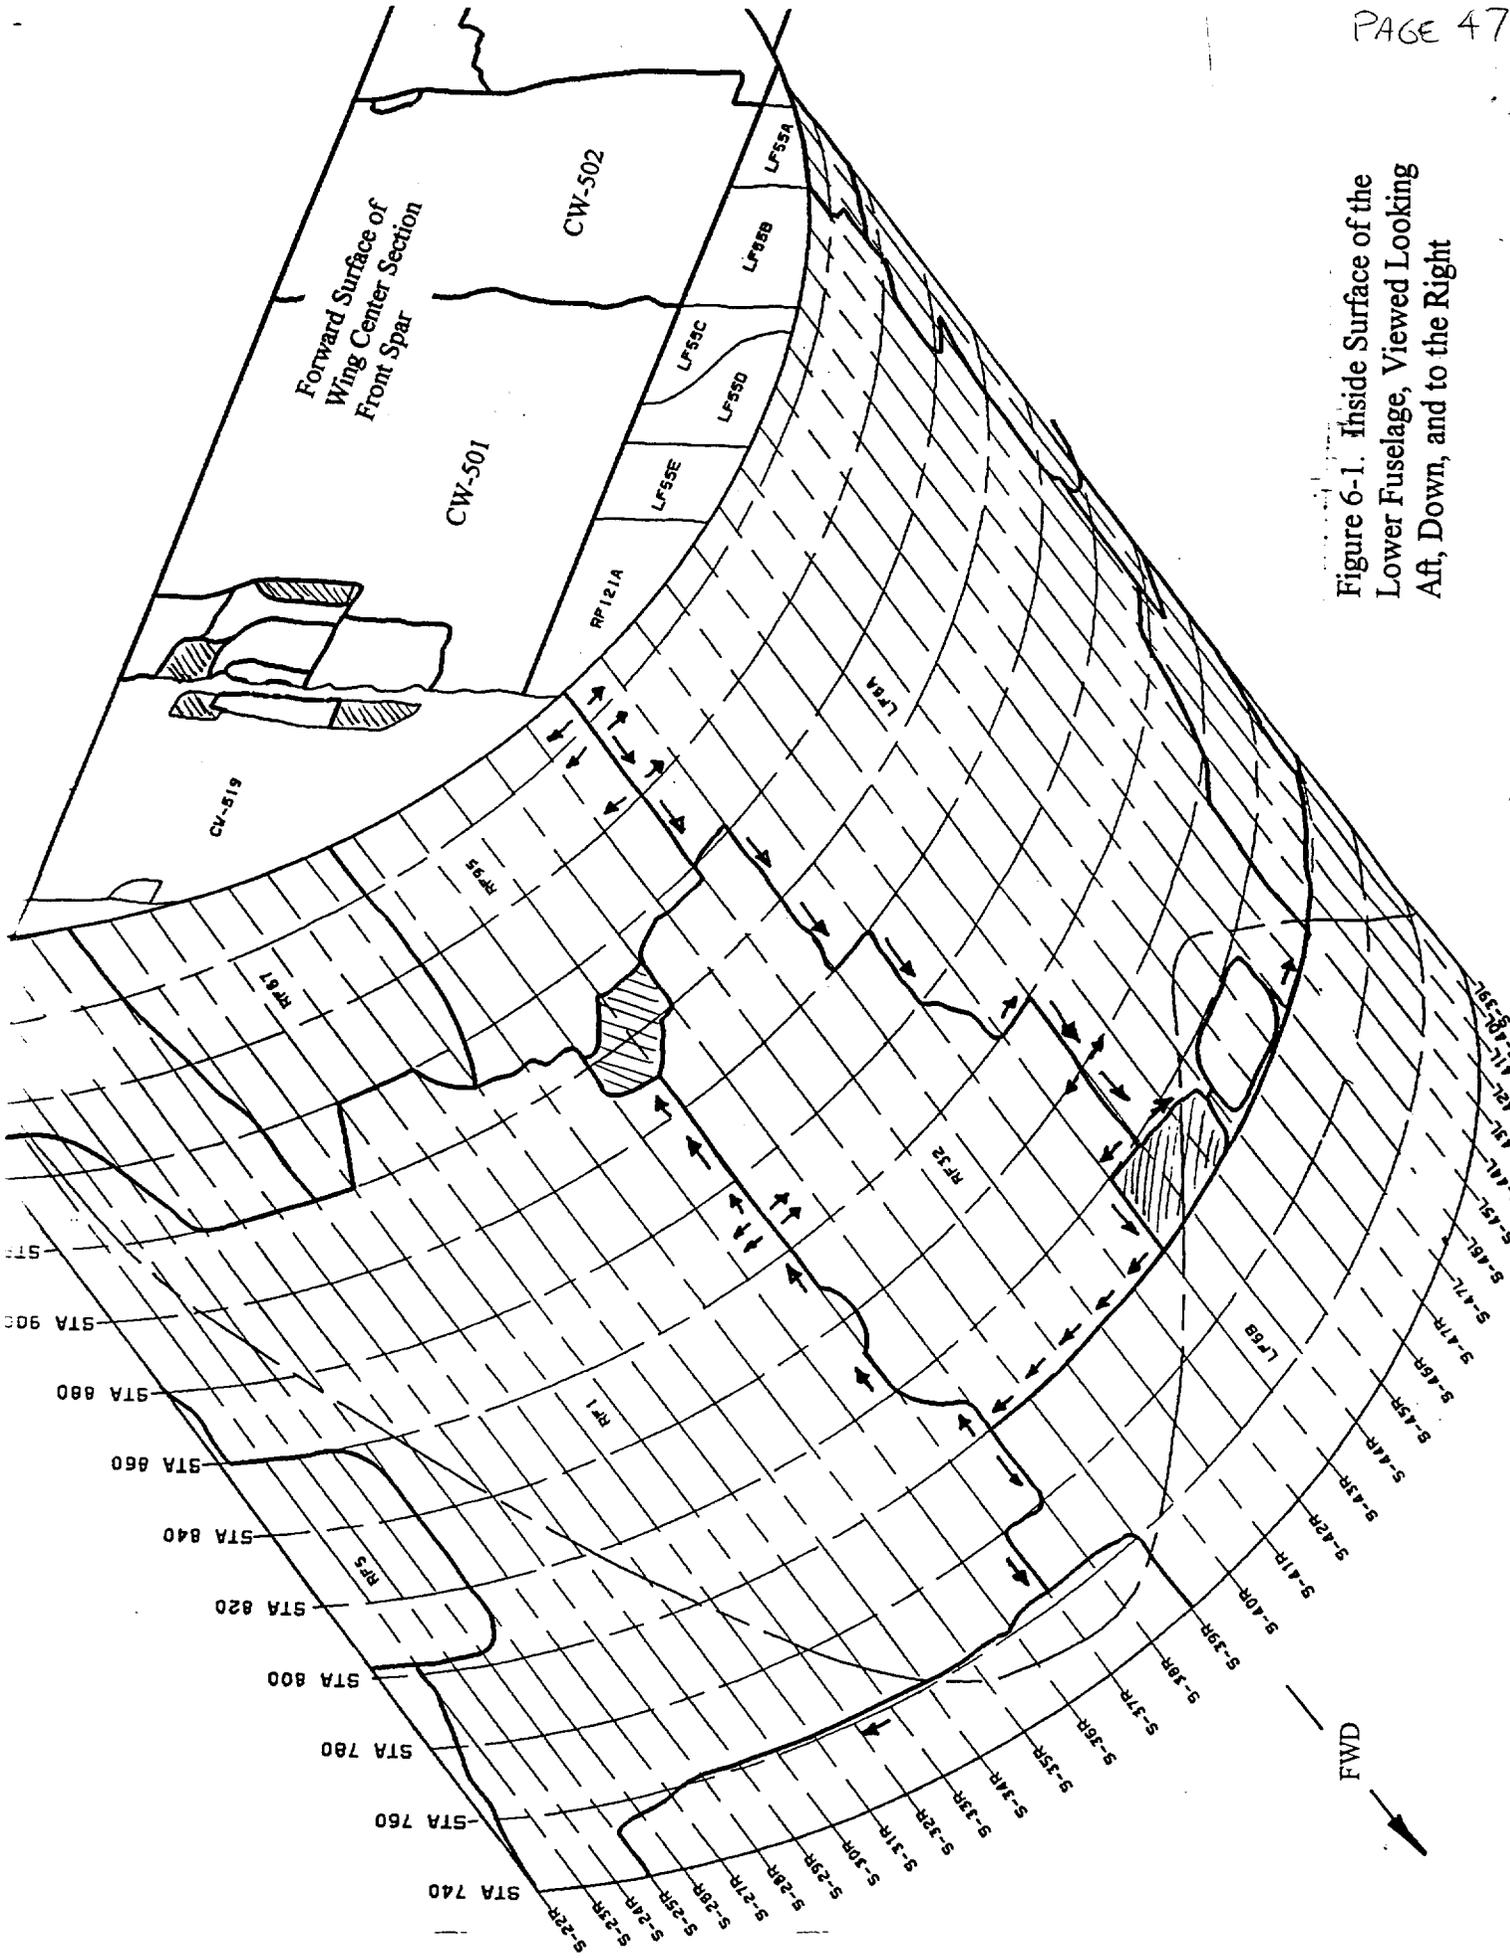
All of the fuselage skin fractures on the pieces from the areas shown in figures 6-1 and 6-2 were examined in detail. No evidence of fractures originating from pre-existing fatigue or corrosion damage was found. Some of the skin fractures progressed along a row of rivets, either longitudinally along a stringer or lap joint, or circumferentially along a frame attachment location. Others were in the skin away from a row of rivets. None of the fuselage pieces from below the window belt in this area contained signs of longitudinal compression buckling. Fractures that were along a row of rivet holes and were consistent with in-plane⁴ loading (hoop or longitudinal tension with the possible presence of in-plane shear) were sequenced as occurring before fractures bending or out-of-plane shear deformation. Three types of earlier fractures were identified:

Unlabeled arrowheads oriented parallel to skin fracture locations in figures 6-1 and 6-2 indicate the location and direction of propagation of the earlier fuselage skin fractures. In places where the earlier longitudinal fractures did not have features indicating a crack propagation direction, arrowheads perpendicular to the separation indicate the tension loading that is consistent with the fracture features. The earlier fuselage skin fractures discussed above separated the right edge, the forward edge, and a portion of the left edge of a combined piece from the bottom of the fuselage (pieces LF6A and LF24A). The earlier fractures also progressed nearly completely around the circumference of piece RF32 and circumferentially across the bottom of the fuselage from S33L to S32R.

Additional fuselage skin fractures with features indicative of separation under a combined tension and either bending or out-of-plane shear loads were found on the red area pieces from the left side of the fuselage and are indicated by the arrows labeled with a "1" or "2" in a circle in figure 6-2. These fracture areas stemmed from the earlier cracks or were along the bottom row of rivets at a lap joint. Fracture areas labeled with "1" contained bending deformation and fracture areas labeled with "2" contained out-of-plane shear deformation. These additional fractures nearly completed the separation of a large combined piece from the bottom of the fuselage (combined pieces LF6A, LF24A, LF95, and LF55A).

Fuselage skin fracture areas not indicated by arrowheads in figures 6-1 and 6-2 were classified as later fractures.

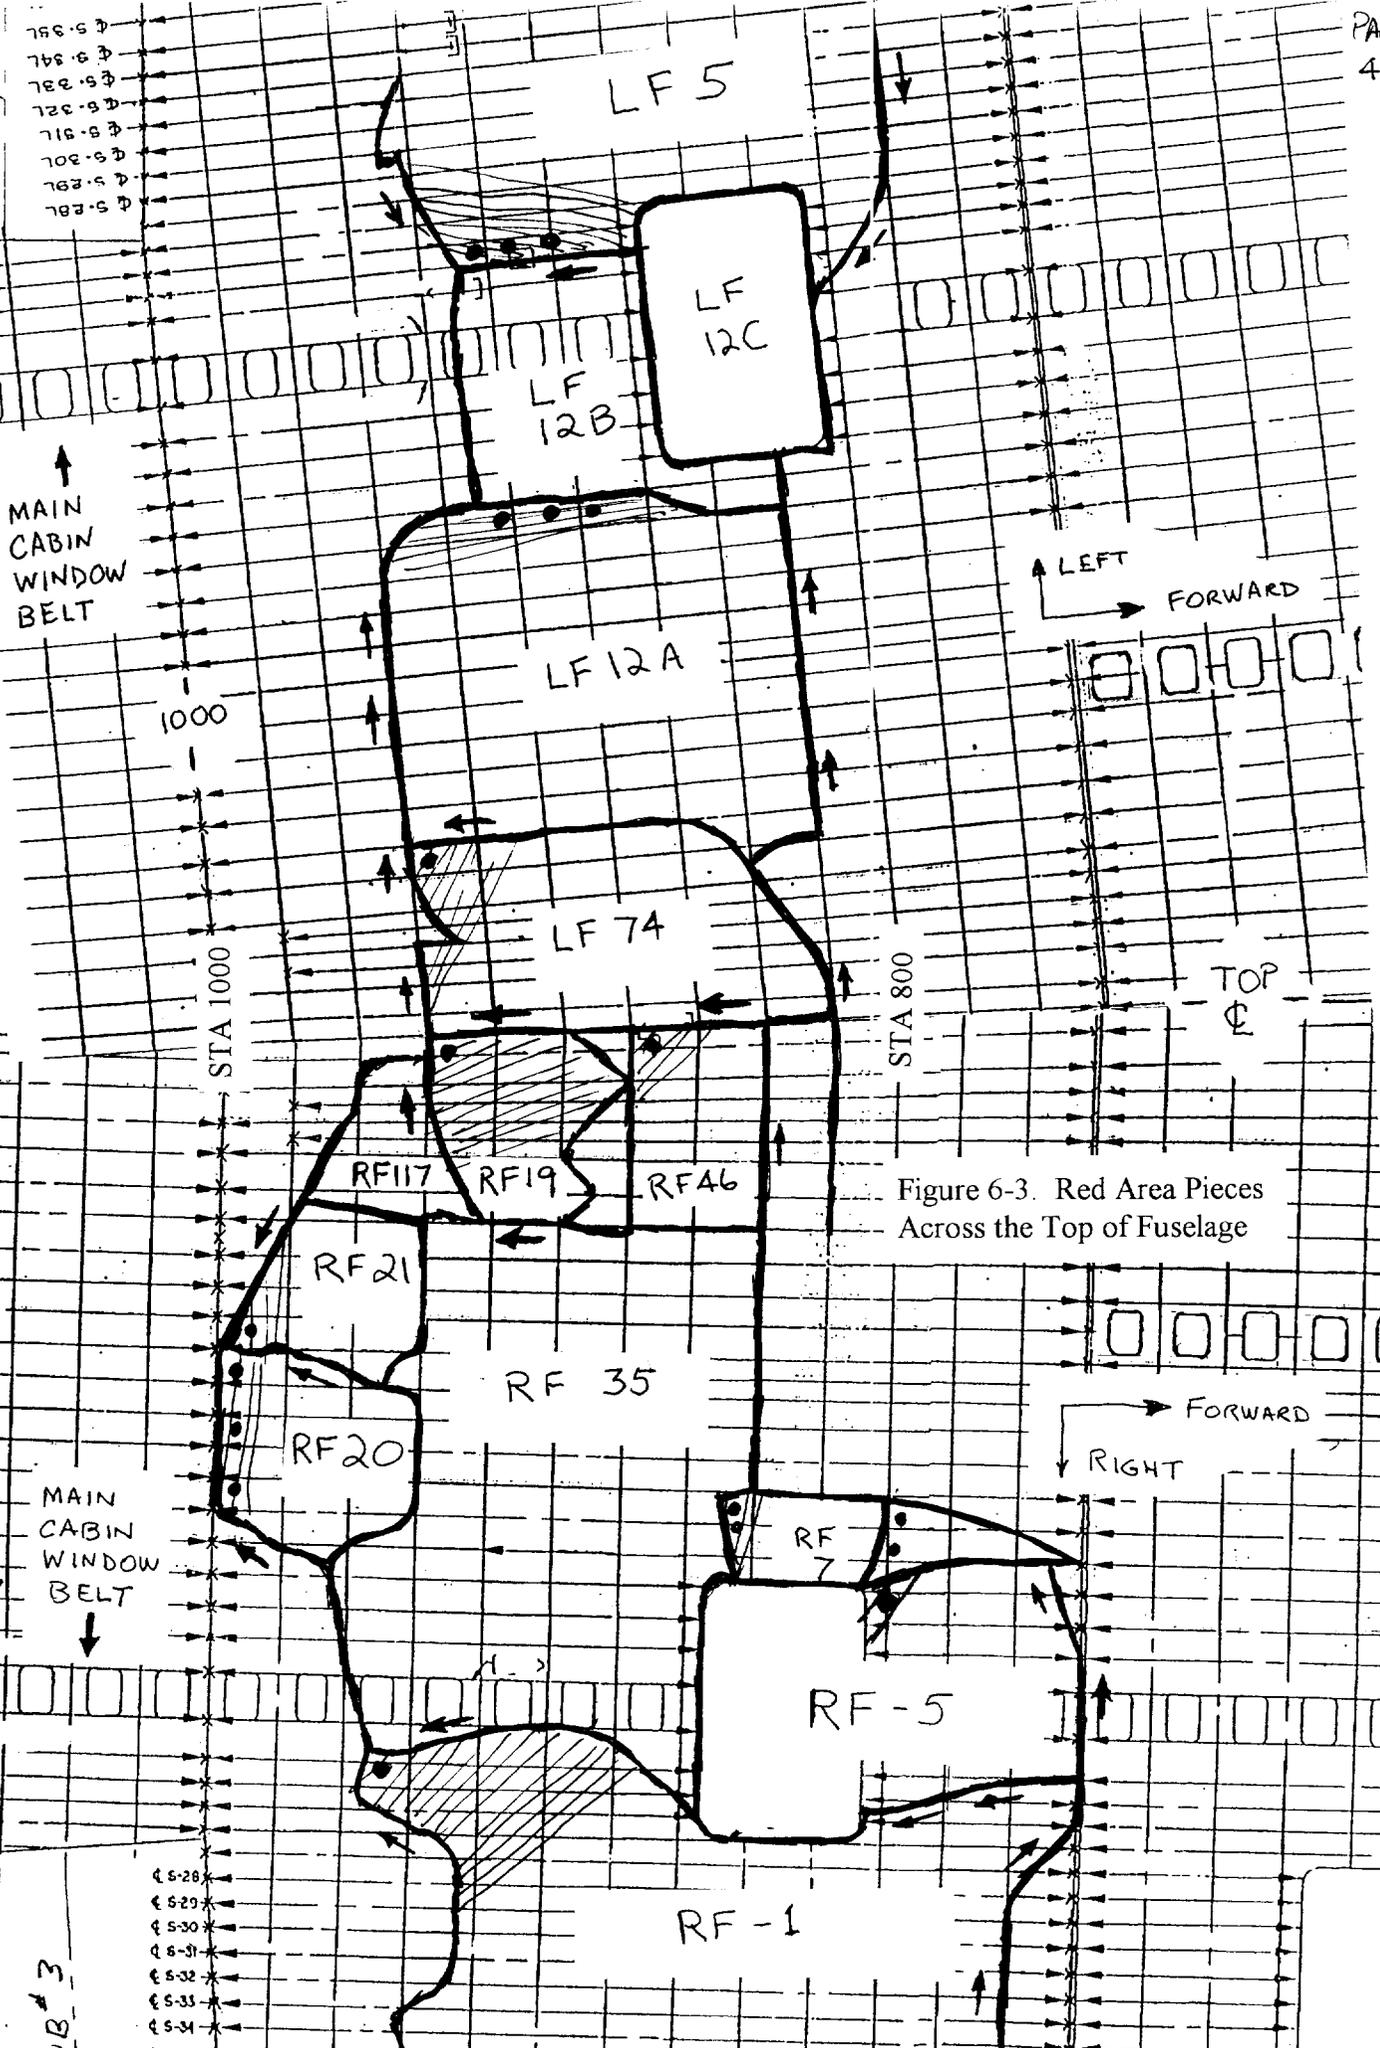
Figure 6-3. Red Area Pieces Across the Top of Fuselage

Figure 6-3 shows a stringer diagram of the fuselage in the area above the main deck window belts. The fracture locations in this diagram are denoted by the dark lines. All fractures in these fuselage skin pieces were "later" fractures, as defined in the section addressing the structure below the main deck window belts. Fracture directions of the fuselage skin structure above the main deck window belts are indicated by the arrowheads adjacent to the fractures in figure 6-3.

Many of the red area fuselage structure pieces from above the window belts contained peeling deformation to the skin, with a decreasing radius of bend toward the end of the peel. Peeled areas were typically not attached to stringers or frames. The peels were created as if the main portion of the piece was moving outboard, away from the fuselage, with the point of the peel being the final point of separation. Both the fracture directions in the skin and the location
