LOG # RF 70 RF 10-2496

TARGET # B167 YELLOW

FUSELAGE SKIN SEGMENT AT FWD CARGO DOOR, LWR FWD CORNER, STA 520 TO 580, STG 34R TO 43R

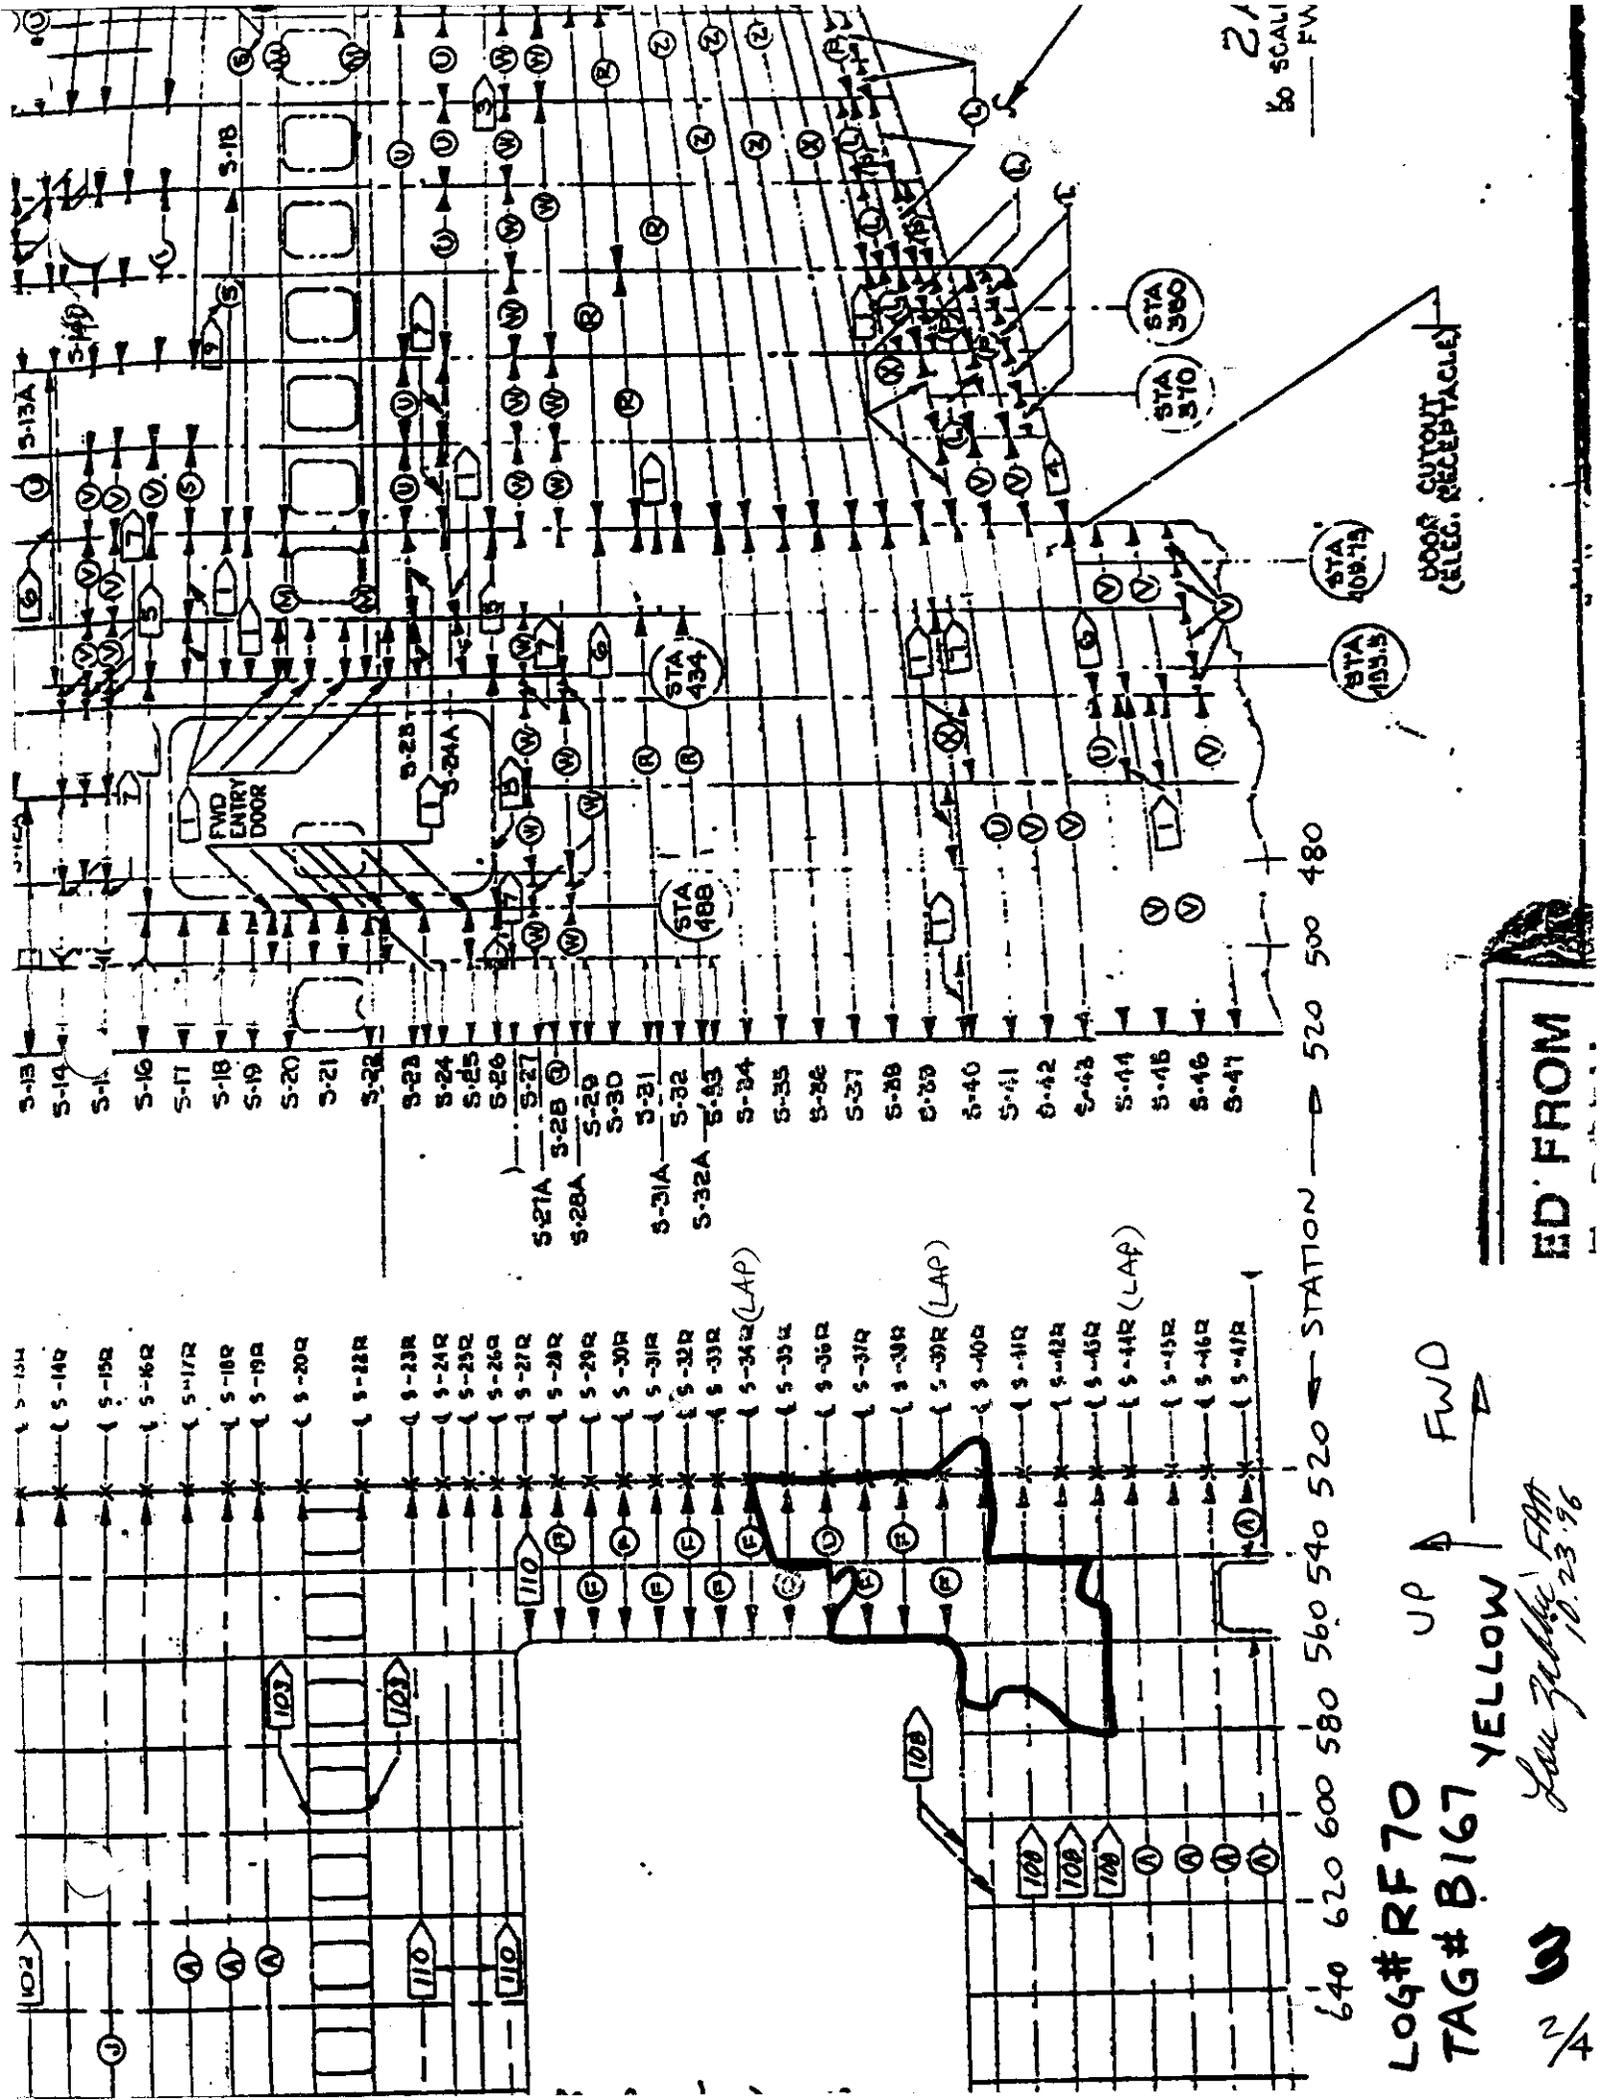
LOG# RF 70
TAG# B167
UP → FWD

- 1) THE SEGMENT SKIN IS A BONDED SKIN ASSEMBLY WITH A COMPOSITE SKIN THICKNESS OF APPROXIMATELY 0.11 INCH.
- 2) THE SKIN SHOWS CONSIDERABLE DAMAGE (TEARS, BENDS, PUNCTURE) HOWEVER THE MOST SIGNIFICANT DAMAGE EXISTING IS CHARACTERISTIC BULGING (INWARD) OF THE SKIN IN THE AREAS BETWEEN STRINGERS AND FRAMES. THIS DAMAGE WOULD RESULT FROM A PRESSURE LOADING ACTING INWARDLY APPLIED ACROSS THE OUTSIDE OF THE PANEL.

- 1) STRINGER 35R REMAINS ATTACHED FROM STA 526 TO 540
- 2) STRINGER 36R REMAINS ATTACHED FROM STA 520 TO 540. ~~36R~~
- 3) STRINGER 37R REMAINS ATTACHED FROM STA 520 TO 560 BUT ~~37R~~ IS IN TWO PIECES BROKEN AT STA 540.
- 4) STRINGER 38R REMAINS ATTACHED FROM STA 520 TO 560 BUT IS IN TWO PIECES BROKEN AT STA 540.
- 5) STRINGER 39R REMAINS ATTACHED FROM STA 515 TO 560 BUT IS IN TWO PIECES BROKEN AT STA 532.
- 6) STRINGER 40R (OUTER CHORD OF DOOR SILL) REMAINS ATTACHED FROM STA 512 TO 572 AND IS INTACT BUT BENDS CONCAVE (LOOKING FROM THE OUTSIDE) ALONG ITS LENGTH.
- 7) STRINGER 41R REMAINS ATTACHED FROM STA 540 TO 569
- 8) STRINGER 42R REMAINS ATTACHED FROM STA 540 TO 560.
- 9) STRINGER 43R REMAINS ATTACHED FROM STA 560 TO 580.
- 10) ALL STRINGERS ARE NOTICEABLE DEFORMED ALONG THEIR LENGTHS.

- 1) AT STA 528, THE SILL WEB IS FAILED ACROSS ITS DEPTH AND THE INNER CHORD FLANGE ATTACHED TO THE WEB IS ALSO FAILED
- 2) AT STA 545, THE SILL WEB IS FAILED ACROSS ITS DEPTH AND THE INNER CHORD INNER FLANGE IS SEPARATED FROM THE WEB ATTACHMENT FLANGE FROM STA 545 TO 560.
- 3) THE WEB ATTACH ANGLE ON THE AFT SIDE OF THE STA 540 BODY ~~FRAME~~ FRAME IS SEVERED ALONG ITS RADIUS.
- 4) THE WEB ATTACH ANGLE ON THE AFT SIDE OF THE STA 560 BODY FRAME IS SEVERED ALONG ITS RADIUS.
- 5) THE SILL INNER CHORD IS SEVERED AT STA 560 AND AT THE SEGMENT BOUNDARY, STA 580.

- 1) THE STA 520 BODY FRAME IS NOT PRESENT.
- 2) THE STA 540 BODY FRAME FROM S-37R TO S-40R HAS ITS WEB SEPARATED FROM ITS INBOARD CHORD. IN ADDITION THE WEB IS LAYING OVER AGAINST THE SEMI-MONOCOQUE.
- ~~3) THE BODY~~ THE WEB BELOW S-40½R IS TORN AWAY ALONG WITH BOTH INBOARD AND OUTBOARD FRAME CHORDS.
- 3) THE STA 560 BODY FRAME IS MISSING ITS WEB FROM S-38R & UPWARD. THE INBOARD CHORD CONTINUES UP TO S-34R BUT ITS WEB ATTACHMENT FLANGE IS MISSING FROM S-38R & UP. STILL INTACT ARE A DOOR STOP FTG (& BACKUP FTG) AT ABOUT S-36R, A DOOR LATCH PIN AT S-38R, AND A DOOR ROLLER AT S-37½R.

- 1) AT A NUMBER OF LOCATIONS ARE REMNANTS OF FRAME TO SKIN SHEAR TIES. AT THE MAJORITY OF THESE SITES, ONLY THE SKIN ATTACHMENT LEG REMAINS.
- 2) ON THE STA 540 FRAME AT ABOUT S-40R ARE THE REMNANTS OF A CARGO SIDE GUIDE ROLLER FTG. JUST INBOARD FROM THAT IS A 2" X 2" PIECE OF ROLLER TRAY BASE STILL ATTACHED TO THE FRAME HORIZONTAL (UPPER) CHORD.
- 3) TWO SKIN PENETRATIONS ARE EVIDENT. ONE IS AT STA ~ 523, S-35¼R AND THE OTHER IS AT STA ~ 568, S-41½R. 2
- 4) THERE IS NO APPARENT SOOTING OF THE SEGMENT
- 5) FRACTURE SURFACES APPEAR TO BE DUCTILE FAILURE.
