LOG # RF126
 TARGET # C2460
 COORD: LAT _____
 LONG _____

B. HOCKING
 BOEING
 3/2/97

LARGEST SEGMENT OF PRESSURE DECK
 STRUCTURE, STA 1265 TO 1448, LBL 66.5 TO RBL 114
 (1238 FOR SEAT TRACKS) --

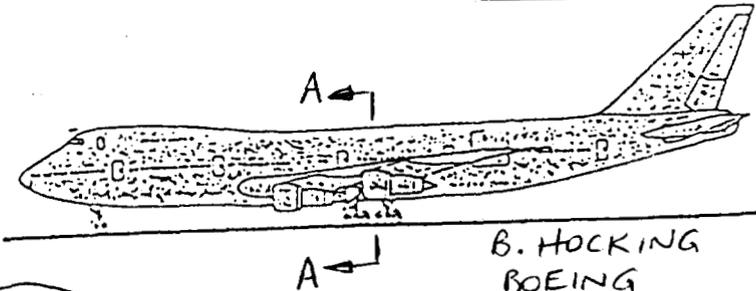
VIEW A-A

PANEL BEND: (SEE P. 2 FOR BEND LINE LOCATION)

THE FORWARD PORTION OF THE PANEL IS BENT DOWNWARD AND AFTWARD INTO THE WING LANDING GEAR WHEELWELL CAVITY. WITH THE PANEL SUSPENDED IN JETASaurus REX, THE FORWARD PORTION HANGS AT AN ANGLE OF APPROXIMATELY 130° FROM THE HORIZONTAL.

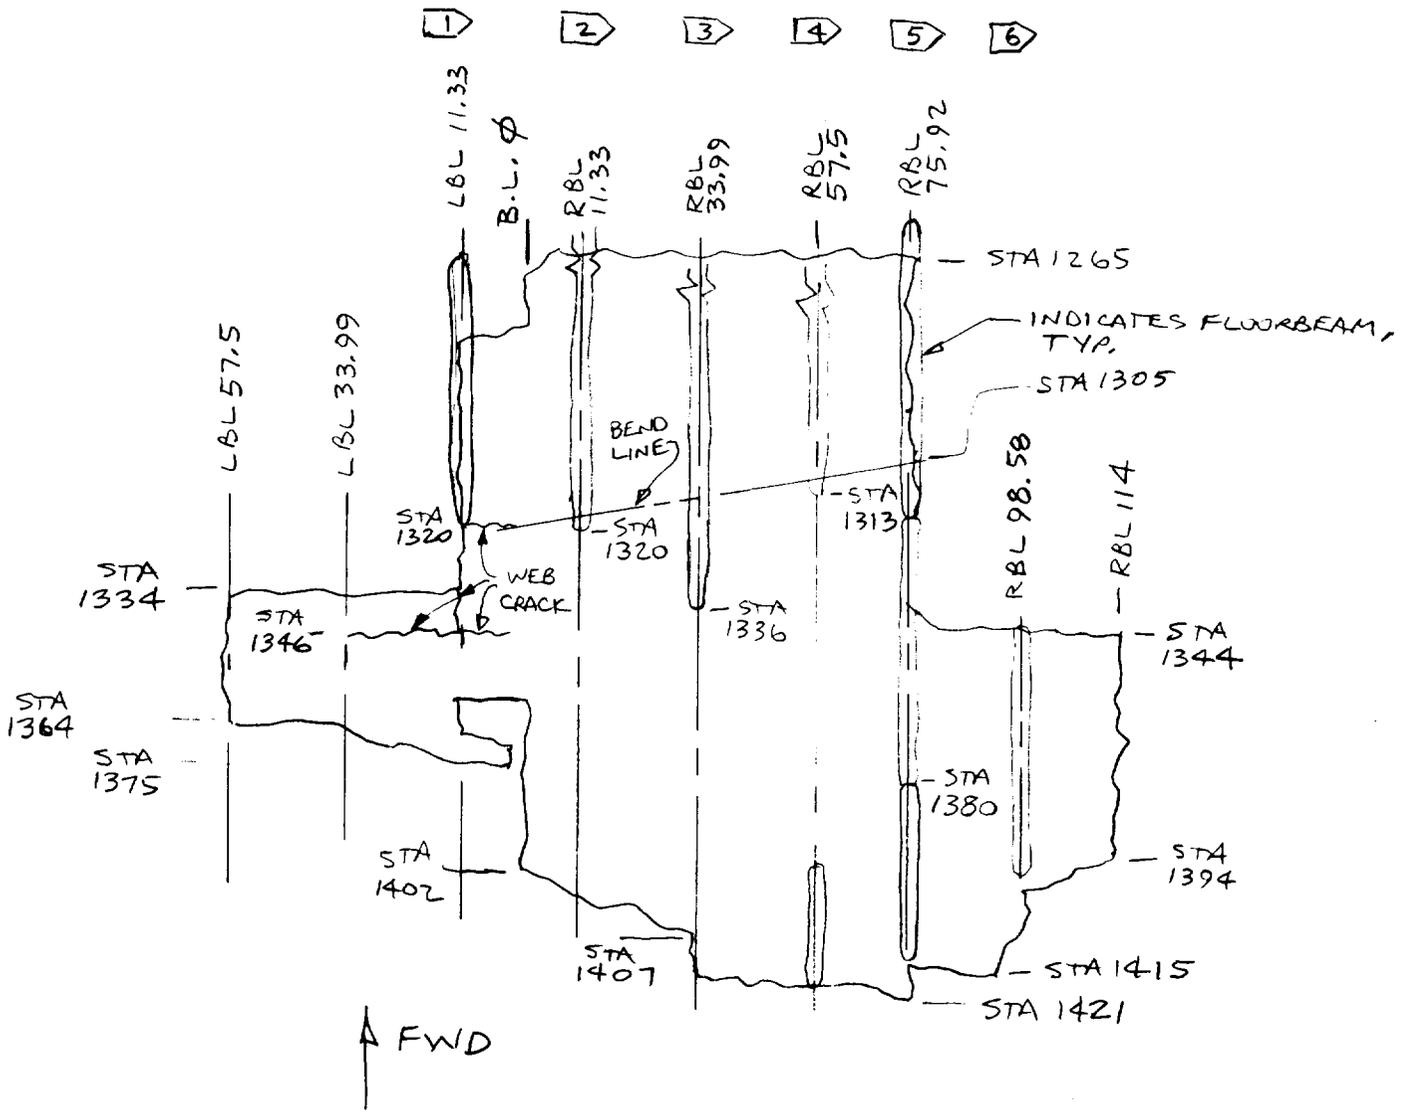
PLAN VIEW

- 1 REMNANT OF LBL 11.33 FLOORBEAM EXTENDS FROM STA 1265 TO WEB CRACK AT 1320.
- 2 REMNANT OF RBL 11.33 FLOORBEAM EXTENDS FROM STA 1245 (FORWARD OF EDGE OF PANEL) TO STA 1320.
- 3 REMNANT OF RBL 33.99 FLOORBEAM EXTENDS FROM STA 1250 (FWD OF PANEL EDGE) TO STA 1336.
- 4 REMNANT OF RBL 57.5 FLOORBEAM EXTENDS FROM STA 1250 (FWD OF PANEL EDGE) TO STA 1313. ANOTHER REMNANT EXTENDS FROM STA 1394 TO STA 1420

- 5) REMNANTS OF RBL 75.92 FLOORBEAM AS DESCRIBED:
- A) A PORTION EXTENDING FROM STA 1260 TO 1320 REMAINS ATTACHED TO THE REGION OF PANEL FORWARD OF THE P. 2 INDICATED BLEND LINE.
 - B) A PORTION EXTENDING FROM 1370 TO 1380 HAS BEEN CUT FROM RF126 AND IS NOW TAGGED AS RF126-1.
 - C) A PORTION EXTENDING FROM STA 1380 TO 1415 REMAINS ATTACHED TO THE PANEL.
- 6) REMNANT OF RBL 98.58 FLOORBEAM EXTENDS FROM STA 1344 TO 1394.

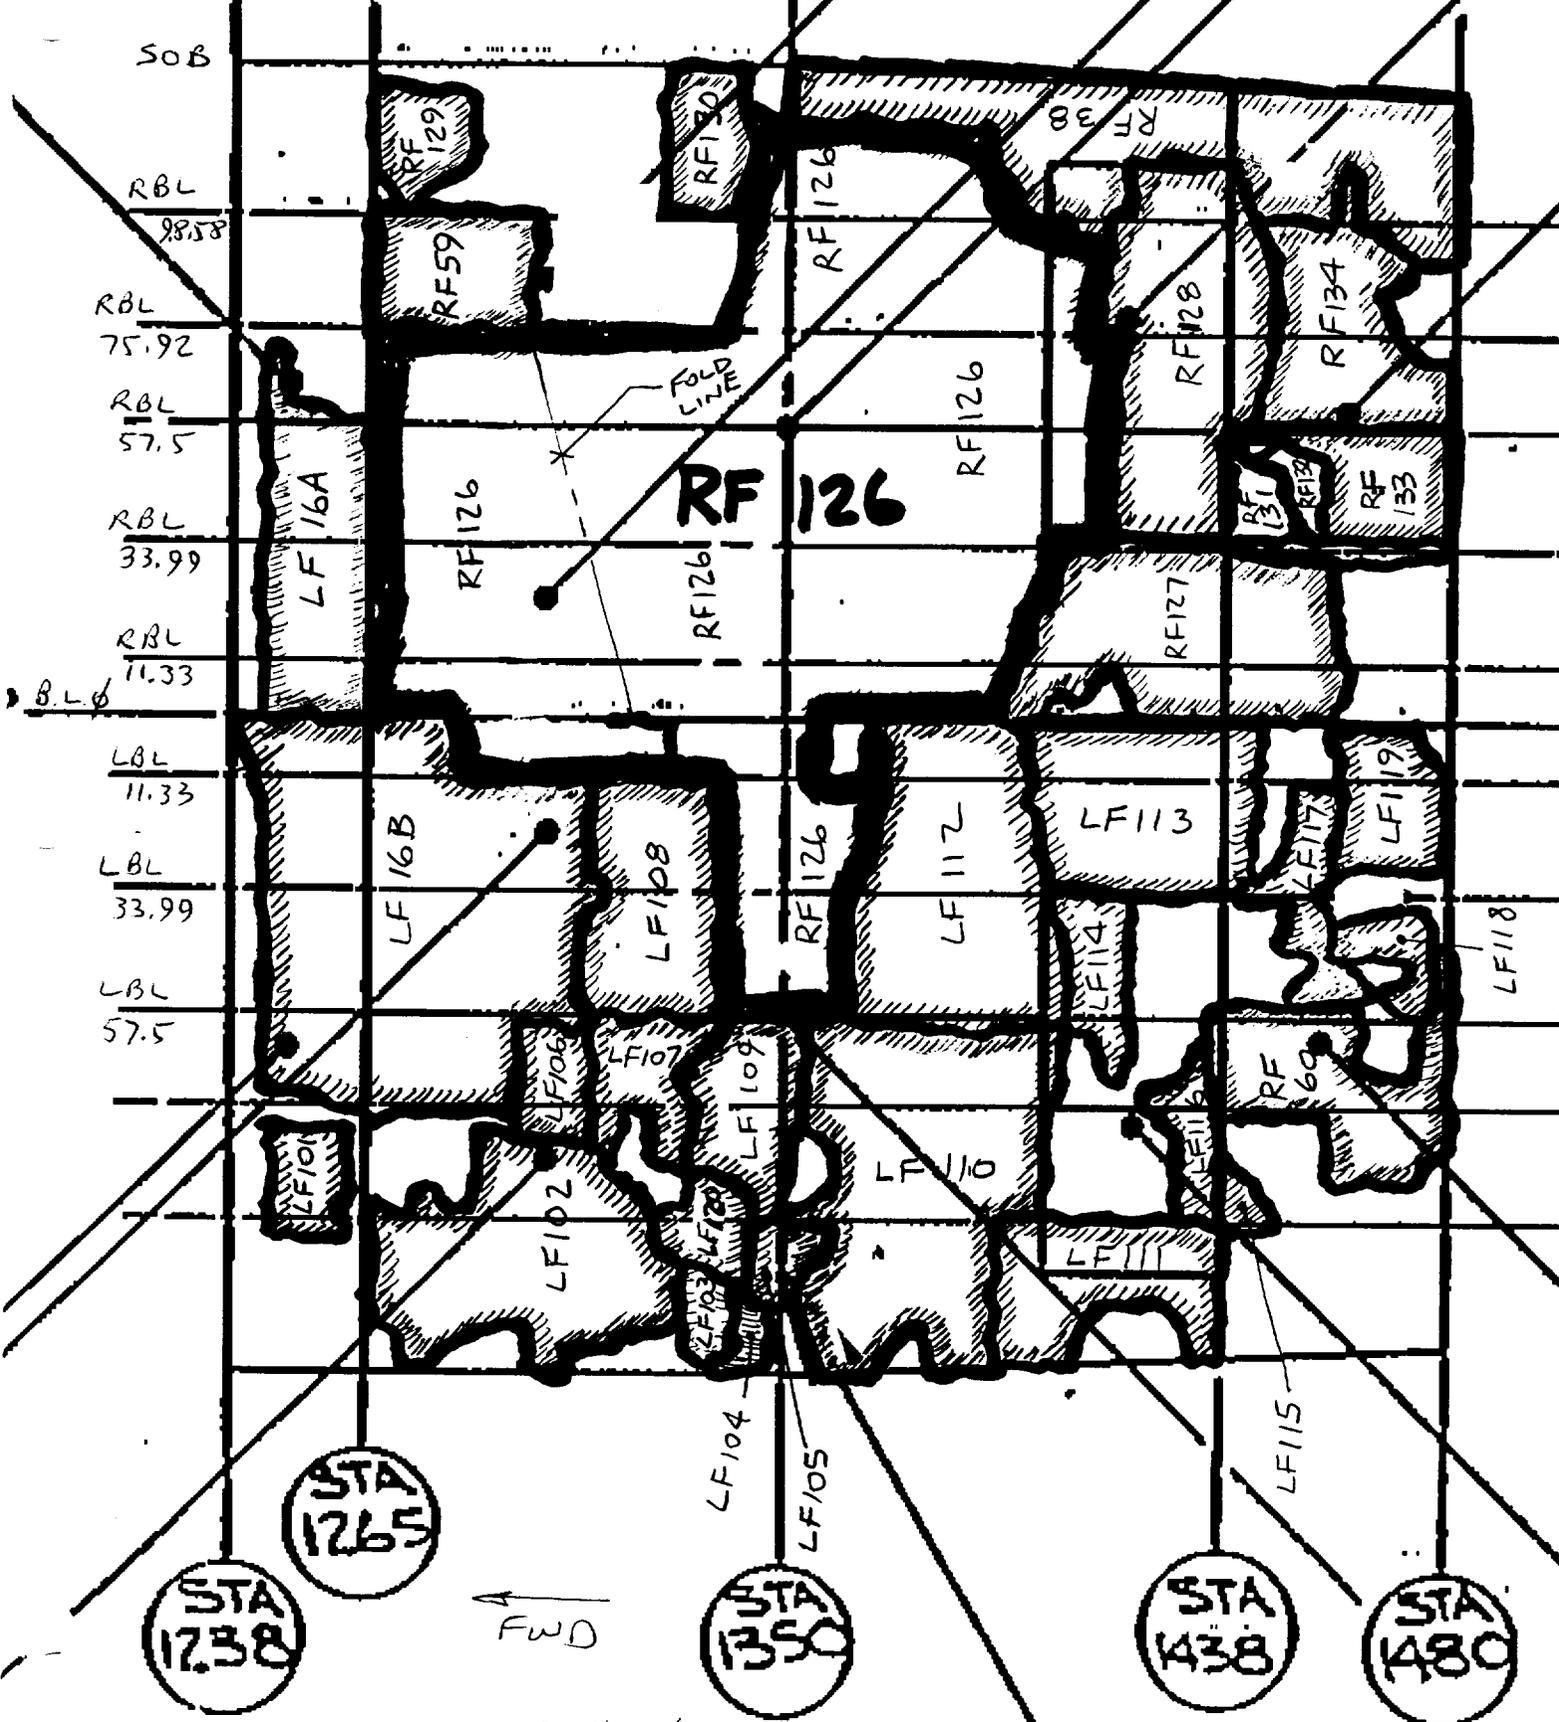
THE STA 1350 BULKHEAD UPPER CHORD

ONLY THE HORIZONTAL FLANGES OF THE STA 1350 BULKHEAD UPPER CHORD REMAIN ATTACHED TO RF126. THE HORIZONTAL FLANGES SEPARATED FROM THE VERTICAL FLANGE ALONG A FRACTURE LINE RUNNING ALONG THE RADII AT THEIR INTERSECTION. ALONG MOST OF THE FRACTURE LINE, FAILURE WAS BIASED TOWARD THE TANGENTS OF THE RADII WITH THE VERTICAL FLANGE.
