Systems 9 - Exhibit No. 9B - Photo 39. Figure 39g. Lo-Z wire from N93105 (model no. FG420A13, serial no. A-16).

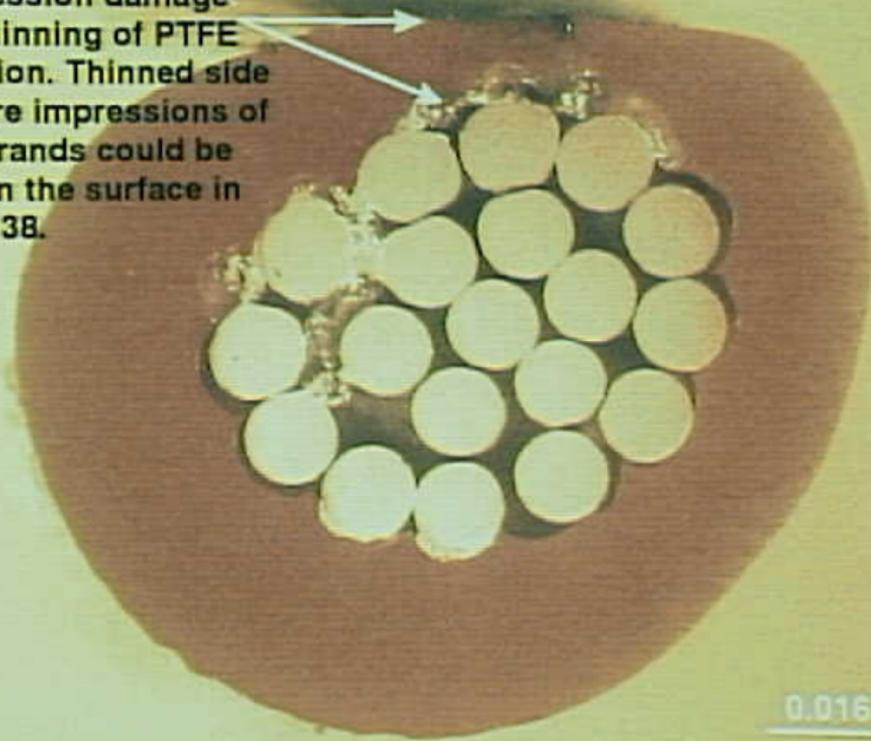
**Cross-sectional view of  
compression damage**  
Note thinning of PTFE  
insulation. Thinned side  
is where impressions of  
wire strands could be  
seen on the surface in  
Figure 38.
