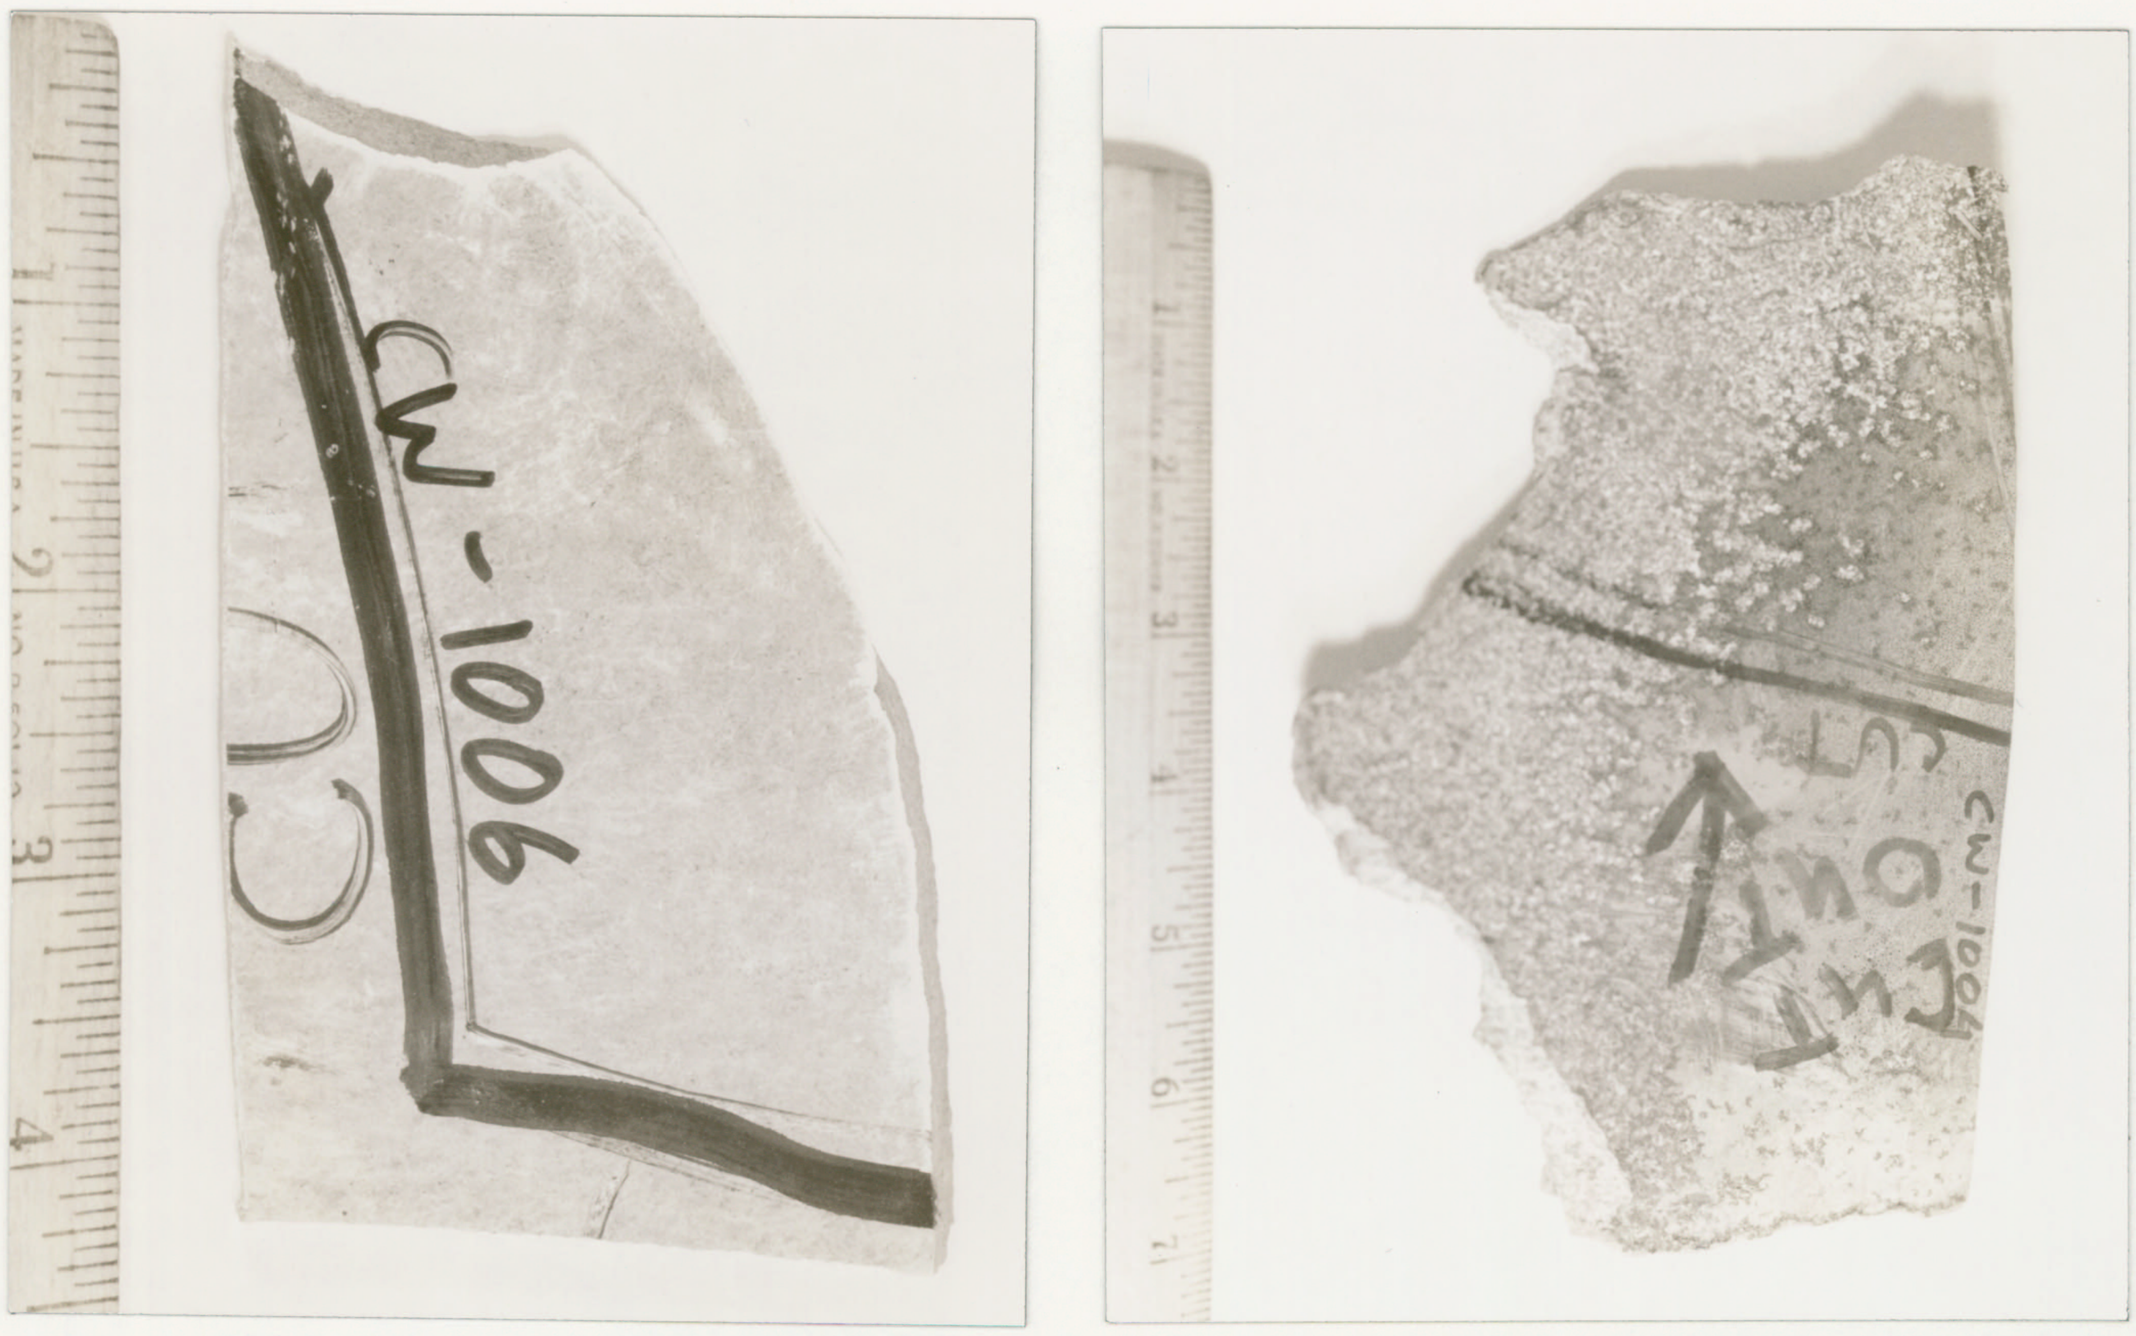
Figure 11. Closer view of the spike tooth fracture area on the sample from piece CW106 of SWB#3, showing the mechanical damage associated with the spike tooth fracture area. (2X)
