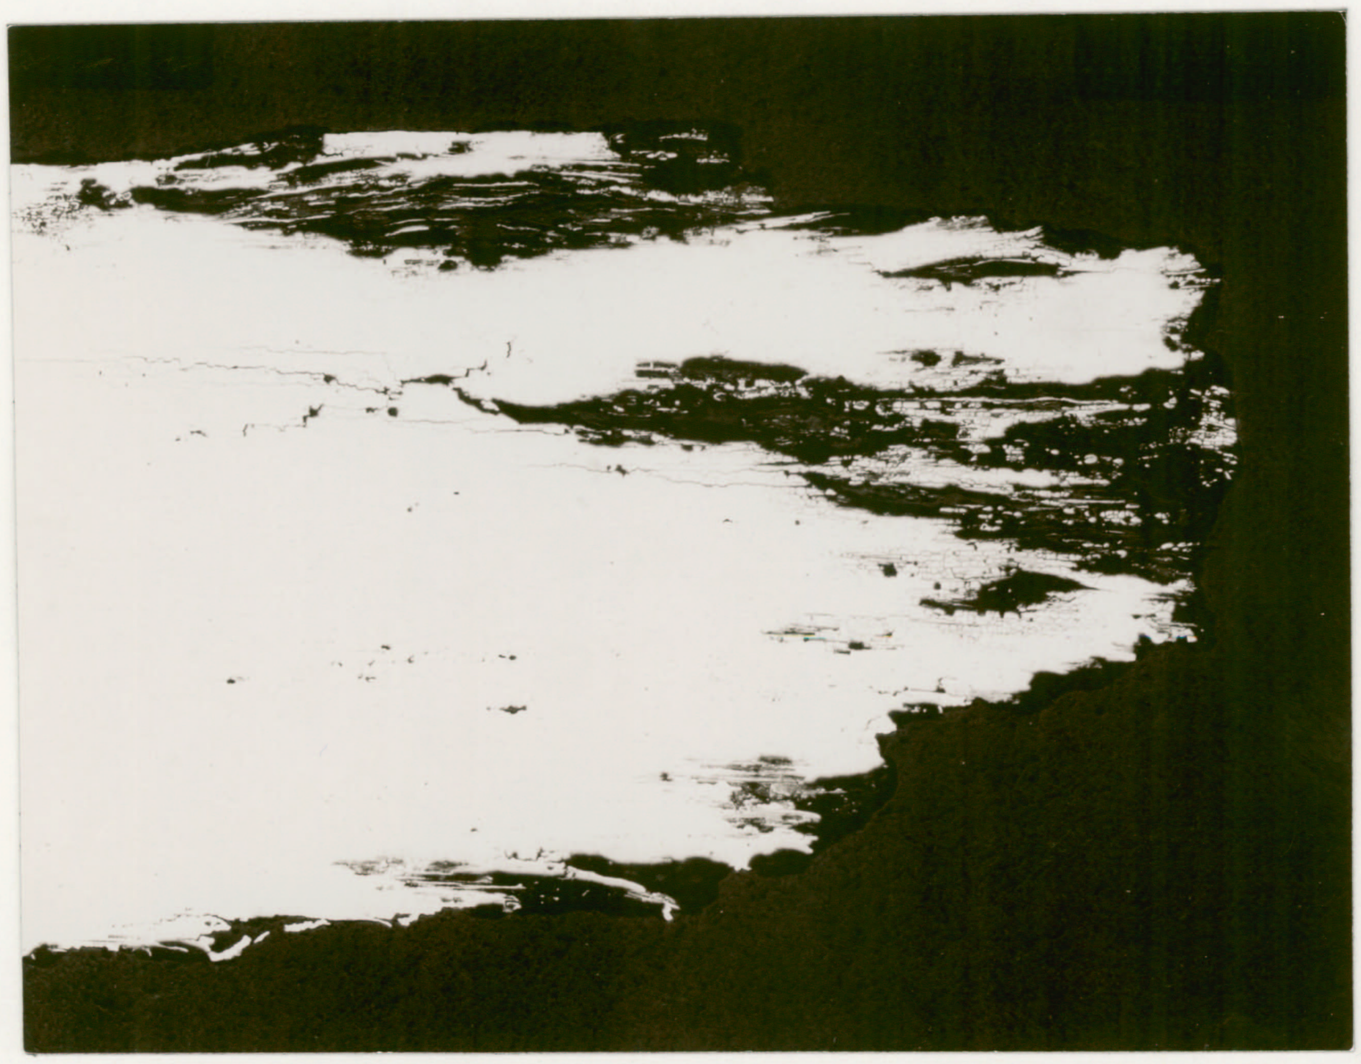
Figure 13. Microstructure unaffected by heat on the section through the fracture on the sample cut from rear spar sample CW1006. (Keller's etchant, 50X)
