**NATIONAL TRANSPORTATION SAFETY BOARD
WASHINGTON, D.C.**

**METALLURGY/STRUCTURAL GROUP CHAIRMAN
FACTUAL REPORT
SEQUENCING STUDY
(57 pages)**

METALLURGY / STRUCTURES SEQUENCING STUDY

Place : East Moriches, New York
Date : July 17, 1996
Airplane : Boeing 747-131, N93119
NTSB No. : DCA96-M-A070

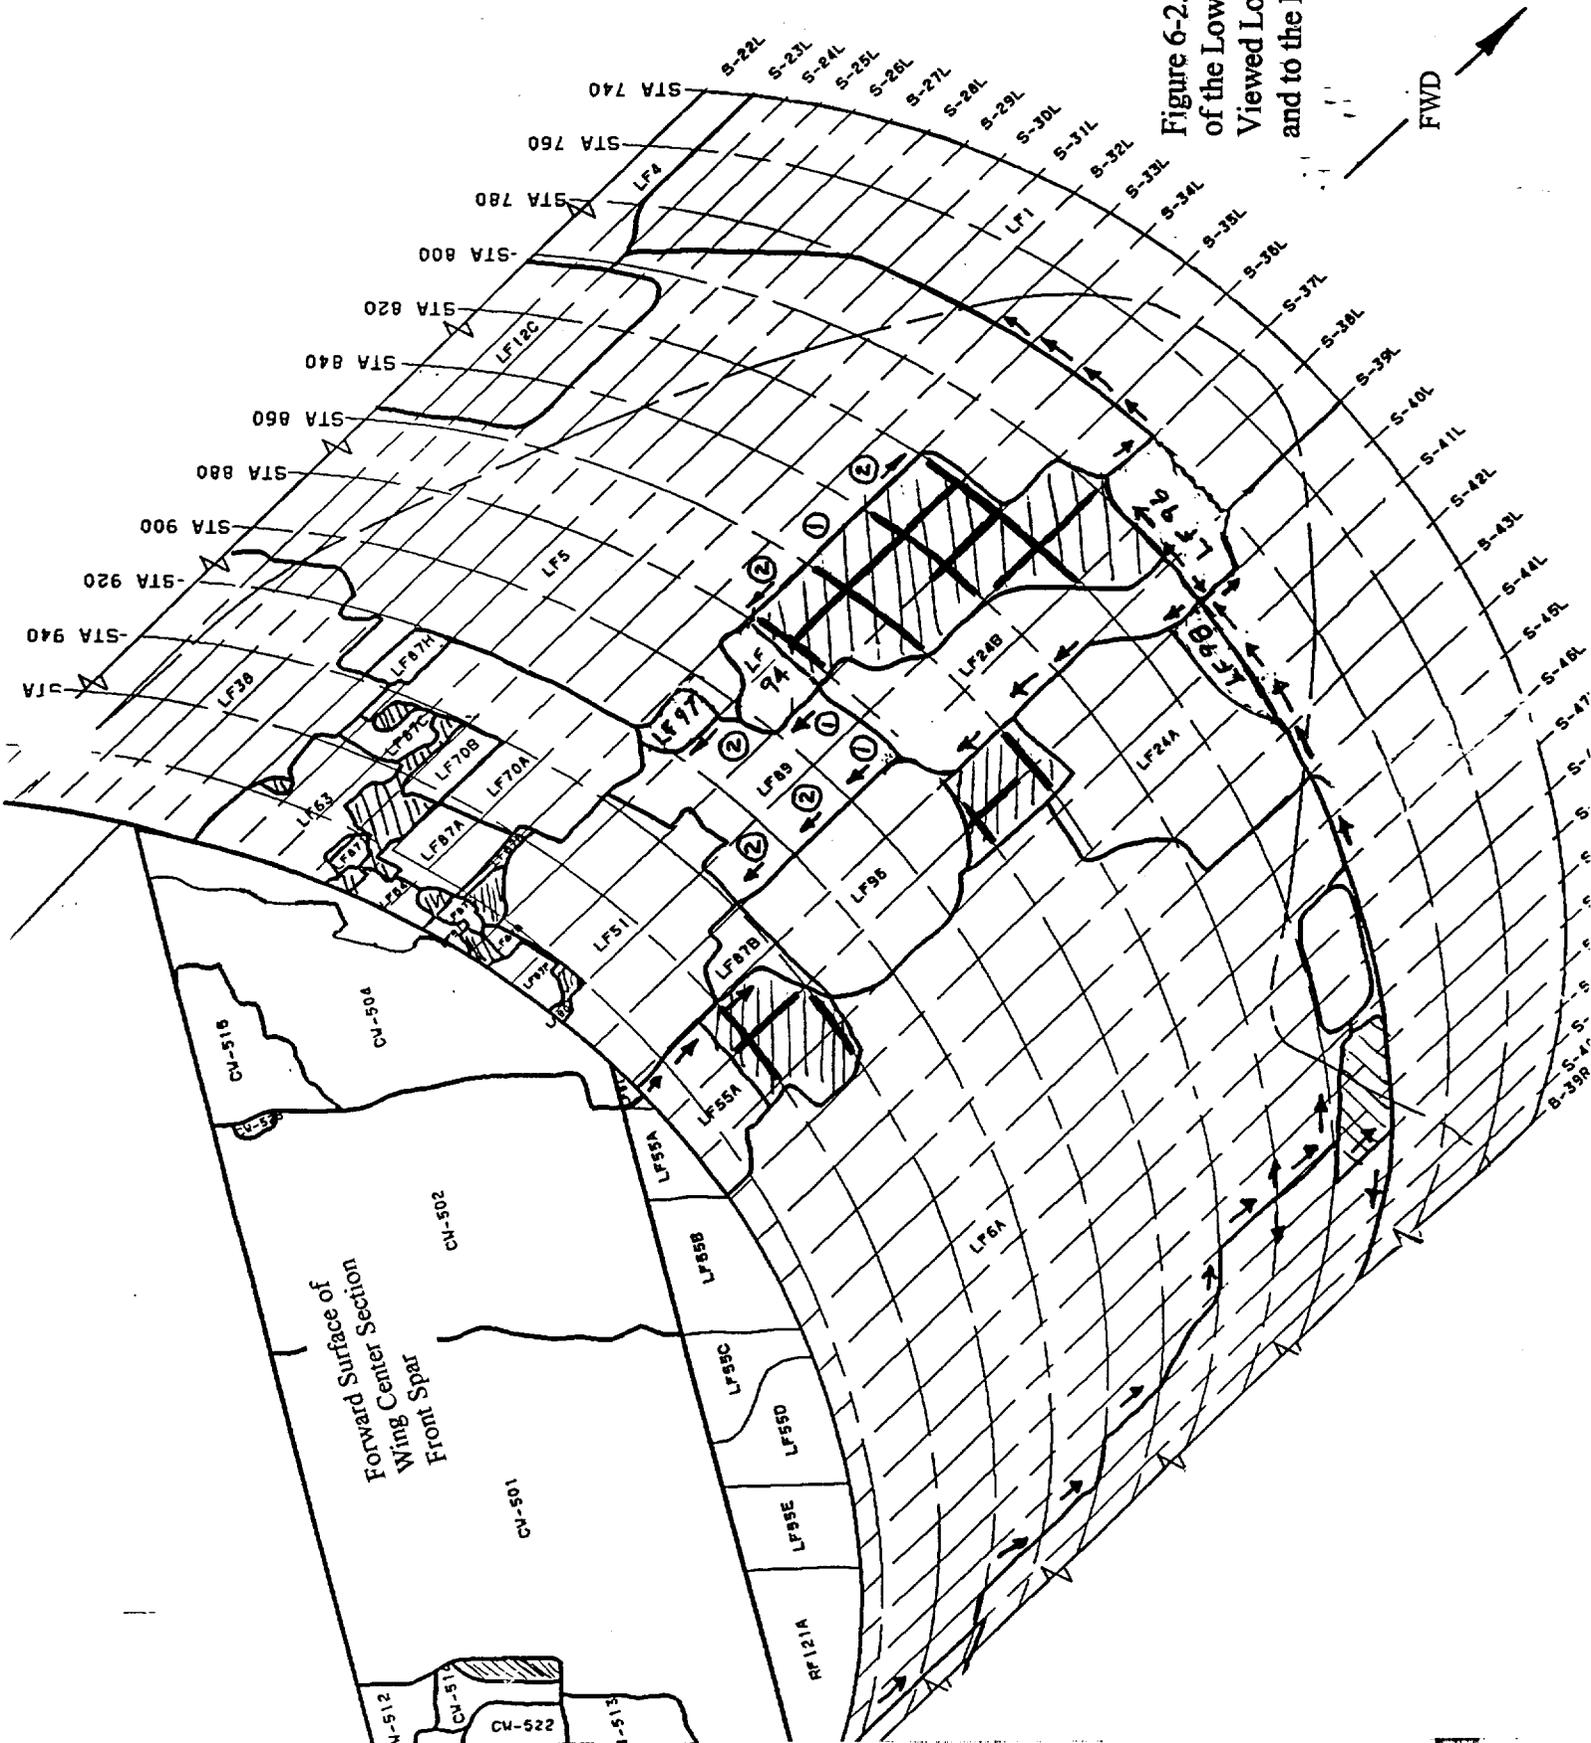
Figure 6-2. Inside Surface of the Lower Fuselage, Viewed Looking Aft, Down, and to the Left

Unlabeled arrowheads oriented parallel to skin fracture locations in figures 6-1 and 6-2 indicate the location and direction of propagation of the earlier fuselage skin fractures. In places where the earlier longitudinal fractures did not have features indicating a crack propagation direction, arrowheads perpendicular to the separation indicate the tension loading that is consistent with the fracture features. The earlier fuselage skin fractures discussed above separated the right edge, the forward edge, and a portion of the left edge of a combined piece from the bottom of the fuselage (pieces LF6A and LF24A). The earlier fractures also progressed nearly completely around the circumference of piece RF32 and circumferentially across the bottom of the fuselage from S33L to S32R.

Additional fuselage skin fractures with features indicative of separation under a combined tension and either bending or out-of-plane shear loads were found on the red area pieces from the left side of the fuselage and are indicated by the arrows labeled with a "1" or "2" in a circle in figure 6-2. These fracture areas stemmed from the earlier cracks or were along the bottom row of rivets at a lap joint. Fracture areas labeled with "1" contained bending deformation and fracture areas labeled with "2" contained out-of-plane shear deformation. These additional fractures nearly completed the separation of a large combined piece from the bottom of the fuselage (combined pieces LF6A, LF24A, LF95, and LF55A).

Fuselage skin fracture areas not indicated by arrowheads in figures 6-1 and 6-2 were classified as later fractures.

- 7.2.10 The ring chord and adjacent fuselage skin at S40R (RBL 66) fractured due to the combined loads described in 7.2.9, initiating the early skin cracking that propagated dynamically forward (first along S40R between pieces LF6A and RF95, then S41R, S42R, and S44R until running to the centerline access cutout between STA 800 and STA 820) and then circumferentially (upward to both the left and right from the bottom center at STA 760 to STA 800), then aft from STA 800 along two cracks, one at S40L and S39L and one at S38R and S37R (reference figures 6-1 and 6-2).

- 7.2.13 A skin crack symmetric to the early crack on the right side (see section 7.2.10, above) initiated on the left side at the ring chord along S39L.

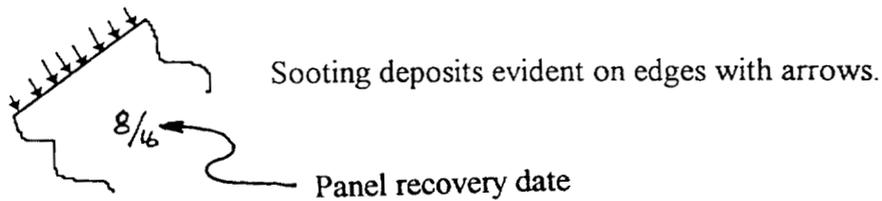
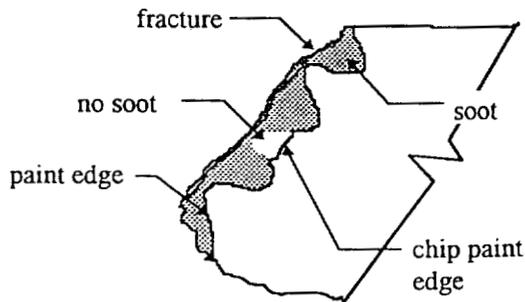
FIGURE 10-1

It can be seen from both the external and internal sooting patterns (figures 10-1 through 10-6) that there is a clear distinction between structure that departed with the left wing and the remainder of the right wing and aft fuselage. Lack of soot accumulation on the large fuselage piece (LF38) above the wing and fuselage pieces along the crown (RF34, RF41, and LF69) indicate that these pieces separated with the left wing. Soot accumulation on the remaining right

Surveyed panels are all recovered from the Green debris field and are located from approximately STA 910 to STA 1600.

Aft of STA 1600, no sooting is evident internally. On the exterior, there is light to moderate sooting extending aft along the entire length of the fuselage from approximately the main deck window belt on the RHS to approximately S-8 on the LHS

Determination primarily made by examining external paint failures near the fracture edge. Soot deposits remain on underlying paint when the top layer peels near fracture.

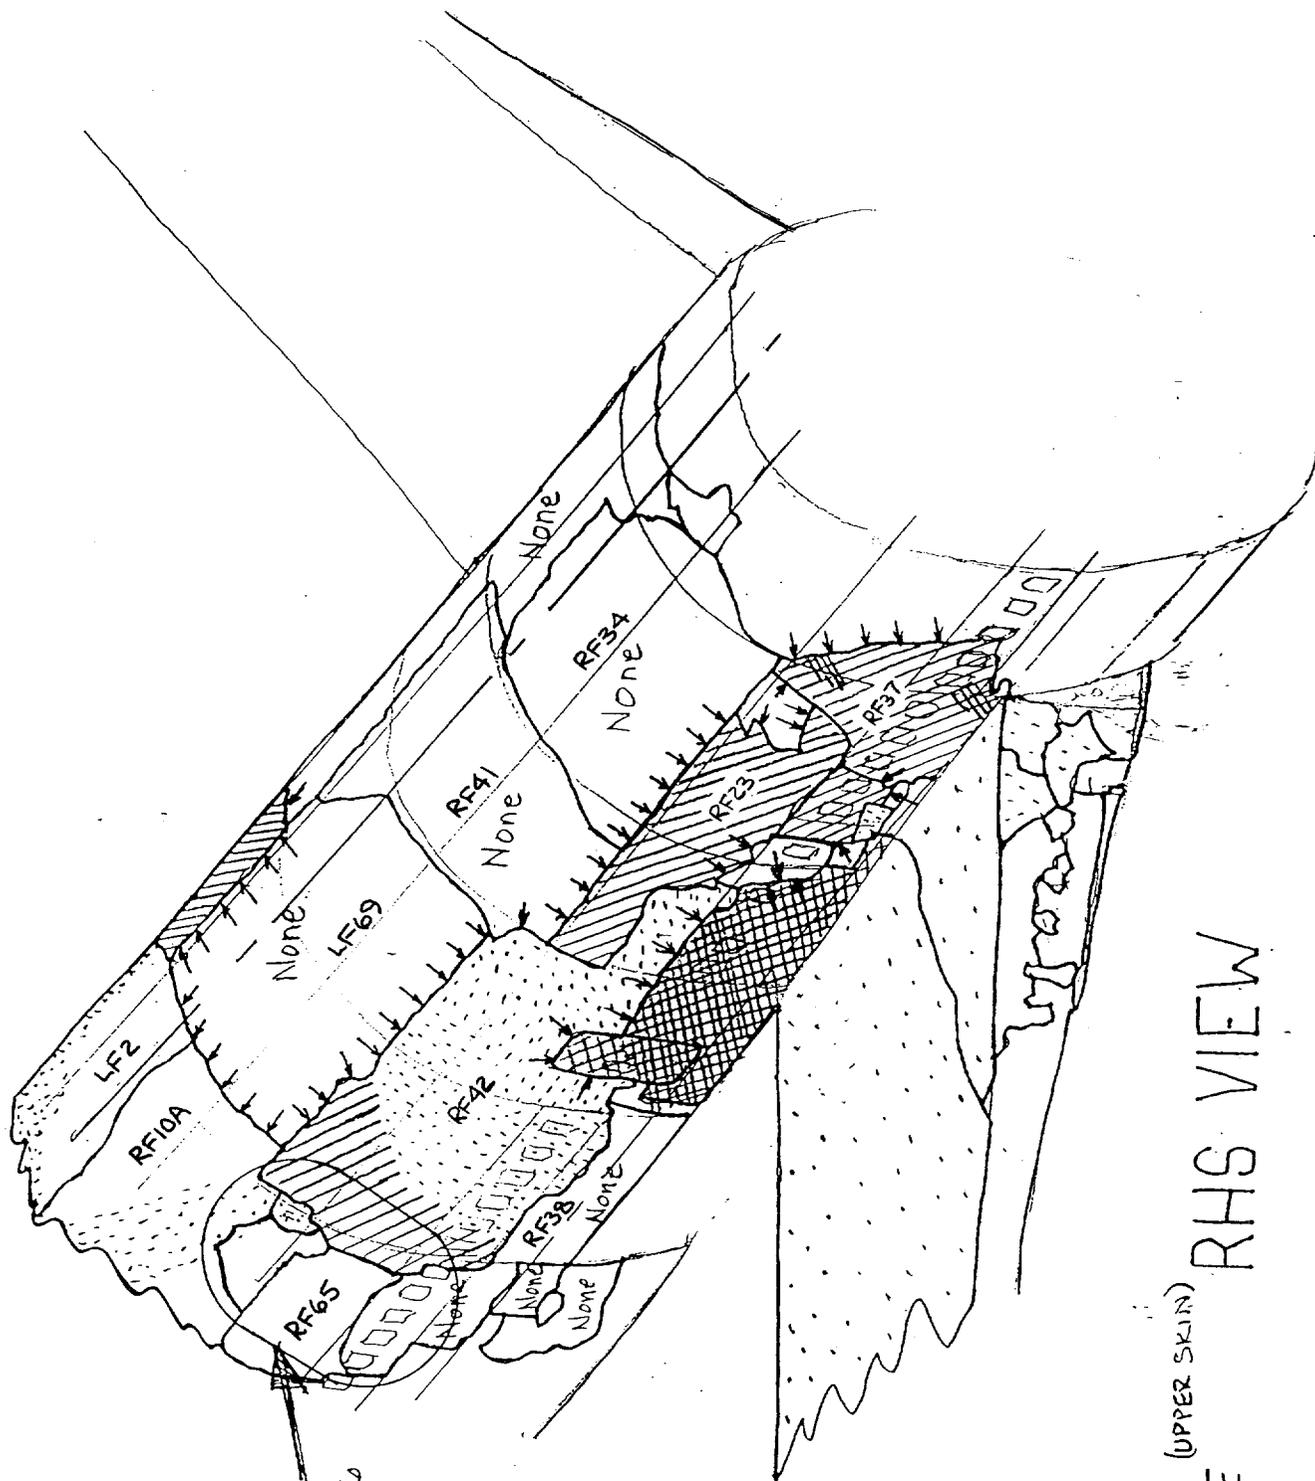
FIGURE 10-5

Following loss of the aft fuselage, some fuselage pieces (including major pieces LF39A, RF42, RF23) and some wheel well structure (including a portion of the keel beam and the STA 1350 bulkhead right of LBL 75 along with the right landing gear beam) remained with the right wing for a period of time and accumulated additional soot from a fire source on the right wing. See figure 10-7 for a diagram of the sooting patterns on the lower body structure between STA 1241 and STA 1480. These pieces subsequently separated before exposure to the major fire associated with the right wing. The right landing gear beam separated from the right wing at the outboard attach point liberating the right wing gear. Heavy soot accumulation and fire damage on pieces RF14 and RF37 indicated that they remained attached to the right wing for some period of time during the major fire. Fuselage piece RF17 was recovered attached to the right wing structure and was severely burned.
