LOG # RF42

TARGET # C 845

REFER FIRE AND EXPLOSION GROUP NOTES FOR FIRE DAMAGE DEBRIS FIELD #1 green

RHS skin segment, STA 1170 to 1500, S-7R to S-24R.

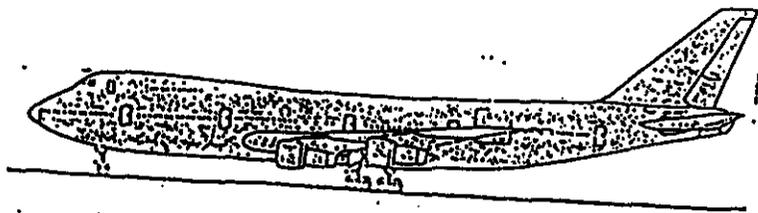
Most frames and all stringers remain attached to the panel. The fwd door edge frame is not attached. The aft edge frame is intact down to stop #2 (8 stops remain). The forward most portion of this panel is folded sharply near STA 1241.

There is a moderate coating of soot or dirt on the exterior of the panel segment. The interior is very lightly sooted. There is a

drastic contrast between this panel and Door 3R (RF28), which exhibits significant burn damage and sooting.

The glass is still intact at the first window aft of the Door. The pane is moderately sooted with the interior surface smooth and the exterior slightly roughened.

The outboard section of the lift-off beam remains attached to the panel. The web from the frame inner chord to the next beam stiffener (~10 inches) is still relatively flat and intact.

① THERE IS ~~COMP~~^A CREASE THAT EXTENDS ON A DIAGONAL LINE FROM STRINGER S13R AND FRAME 1480 DOWNWARD AND FORWARD TO STATION 1372 AND STRINGER S22R. ALL STRINGERS AND FRAMES ALONG THAT LINE EXHIBIT ~~COMPRESSIVE~~ BUCKLING AND FRACTURES.
