LOG # RF 70 RF 10-2496

TARGET # B167 YELLOW

FUSELAGE SKIN SEGMENT AT FWD CARGO DOOR, LWR FWD CORNER, STA 520 TO 580, STG 34R TO 43R

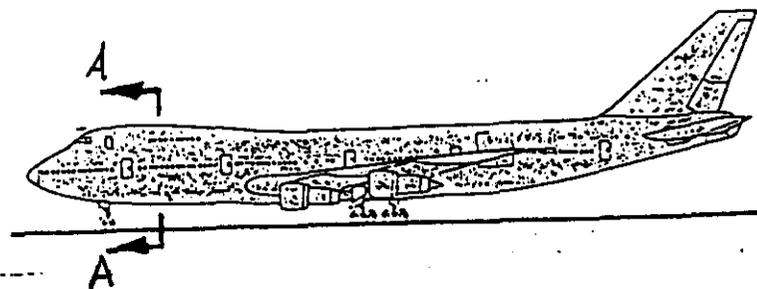
VIEW A-A

- 1) THE SEGMENT SKIN IS A BONDED SKIN ASSEMBLY WITH A COMPOSITE SKIN THICKNESS OF APPROXIMATELY 0.11 INCH.
- 2) THE SKIN SHOWS CONSIDERABLE DAMAGE (TEARS, BENDS, PUNCTURE) HOWEVER THE MOST SIGNIFICANT DAMAGE EXISTING IS CHARACTERISTIC BULGING (INWARD) OF THE SKIN IN THE AREAS BETWEEN STRINGERS AND FRAMES. THIS DAMAGE WOULD RESULT FROM A PRESSURE LOADING ACTING INWARDLY APPLIED ACROSS THE OUTSIDE OF THE PANEL.

- 1) STRINGER 35R REMAINS ATTACHED FROM STA 526 TO 540
- 2) STRINGER 36R REMAINS ATTACHED FROM STA 520 TO 540. ~~36R~~
- 3) STRINGER 37R REMAINS ATTACHED FROM STA 520 TO 560 BUT ~~37R~~ IS IN TWO PIECES BROKEN AT STA 540.
- 4) STRINGER 38R REMAINS ATTACHED FROM STA 520 TO 560 BUT IS IN TWO PIECES BROKEN AT STA 540.
- 5) STRINGER 39R REMAINS ATTACHED FROM STA 515 TO 560 BUT IS IN TWO PIECES BROKEN AT STA 532.
- 6) STRINGER 40R (OUTER CHORD OF DOOR SILL) REMAINS ATTACHED FROM STA 512 TO 572 AND IS INTACT BUT BENDS CONCAVE (LOOKING FROM THE OUTSIDE) ALONG ITS LENGTH.
- 7) STRINGER 41R REMAINS ATTACHED FROM STA 540 TO 569
- 8) STRINGER 42R REMAINS ATTACHED FROM STA 540 TO 560.
- 9) STRINGER 43R REMAINS ATTACHED FROM STA 560 TO 580.
- 10) ALL STRINGERS ARE NOTICEABLE DEFORMED ALONG THEIR LENGTHS.

- 1) AT STA 528, THE SILL WEB IS FAILED ACROSS ITS DEPTH AND THE INNER CHORD FLANGE ATTACHED TO THE WEB IS ALSO FAILED
- 2) AT STA 545, THE SILL WEB IS FAILED ACROSS ITS DEPTH AND THE INNER CHORD INNER FLANGE IS SEPARATED FROM THE WEB ATTACHMENT FLANGE FROM STA 545 TO 560.
- 3) THE WEB ATTACH ANGLE ON THE AFT SIDE OF THE STA 540 BODY ~~FRAME~~ FRAME IS SEVERED ALONG ITS RADIUS.
- 4) THE WEB ATTACH ANGLE ON THE AFT SIDE OF THE STA 560 BODY FRAME IS SEVERED ALONG ITS RADIUS.
- 5) THE SILL INNER CHORD IS SEVERED AT STA 560 AND AT THE SEGMENT BOUNDARY, STA 580.

- 1) THE STA 520 BODY FRAME IS NOT PRESENT.
- 2) THE STA 540 BODY FRAME FROM S-37R TO S-40R HAS ITS WEB SEPARATED FROM ITS INBOARD CHORD. IN ADDITION THE WEB IS LAYING OVER AGAINST THE SEMI-MONOCOQUE.
- ~~3) THE BODY~~ THE WEB BELOW S-40½R IS TORN AWAY ALONG WITH BOTH INBOARD AND OUTBOARD FRAME CHORDS.
- 3) THE STA 560 BODY FRAME IS MISSING ITS WEB FROM S-38R & UPWARD. THE INBOARD CHORD CONTINUES UP TO S-34R BUT ITS WEB ATTACHMENT FLANGE IS MISSING FROM S-38R & UP. STILL INTACT ARE A DOOR STOP FTG (& BACKUP FTG) AT ABOUT S-36R, A DOOR LATCH PIN AT S-38R, AND A DOOR ROLLER AT S-37½R.

- 1) AT A NUMBER OF LOCATIONS ARE REMNANTS OF FRAME TO SKIN SHEAR TIES. AT THE MAJORITY OF THESE SITES, ONLY THE SKIN ATTACHMENT LEG REMAINS.
- 2) ON THE STA 540 FRAME AT ABOUT S-40R ARE THE REMNANTS OF A CARGO SIDE GUIDE ROLLER FTG. JUST INBOARD FROM THAT IS A 2" X 2" PIECE OF ROLLER TRAY BASE STILL ATTACHED TO THE FRAME HORIZONTAL (UPPER) CHORD.
- 3) TWO SKIN PENETRATIONS ARE EVIDENT. ONE IS AT STA ~ 523, S-35¼R AND THE OTHER IS AT STA ~ 568, S-41½R. 2
- 4) THERE IS NO APPARENT SOOTING OF THE SEGMENT
- 5) FRACTURE SURFACES APPEAR TO BE DUCTILE FAILURE.
