**Residue with high concentrations of copper, silver, and sulfur deposited on PTFE insulation depressions caused by pressure from shielding**

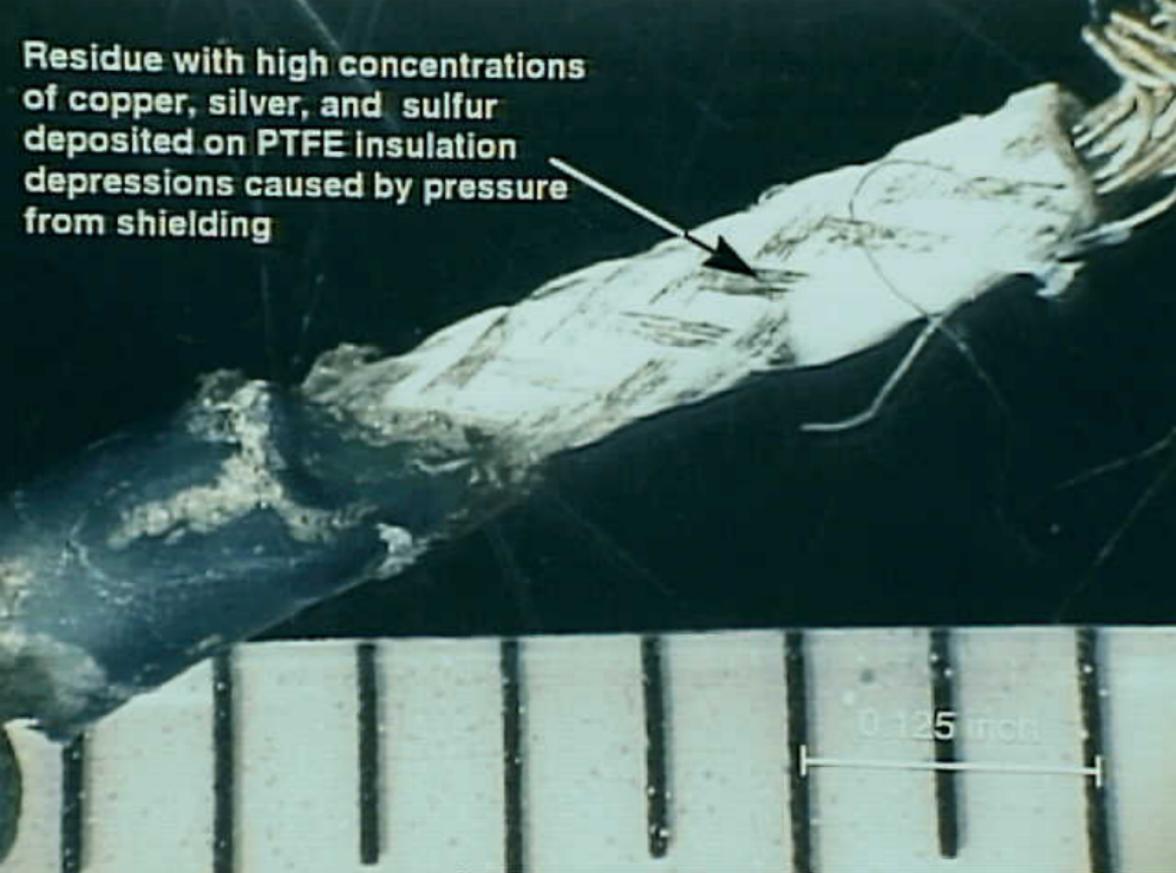
**Systems 9 - Exhibit No. 9B - Photo 10. Figure 10g. Black residue contains high concentration of copper, silver, and sulfur (from N93119, sample bag #14).**
