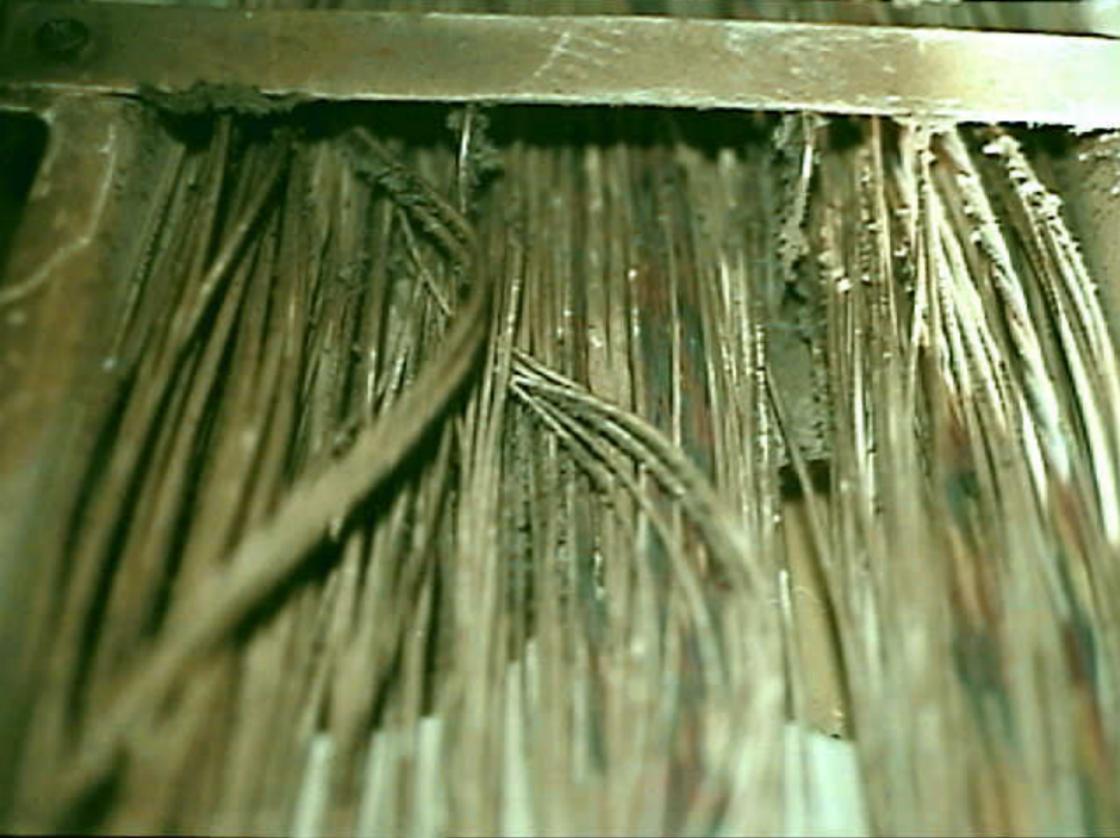
Systems 9 - Photo 24. Airplane 12. B-747 The W480 CWT FQIS wire bundle and other wires in tray over left side of CWT. Photo shows lint and lack of system separation as wires cross each other.
